# SERVICE INDUSTRY NEWS

## Breakthrough in pool plaster research Application technique, not water chemistry, blamed for spot etching

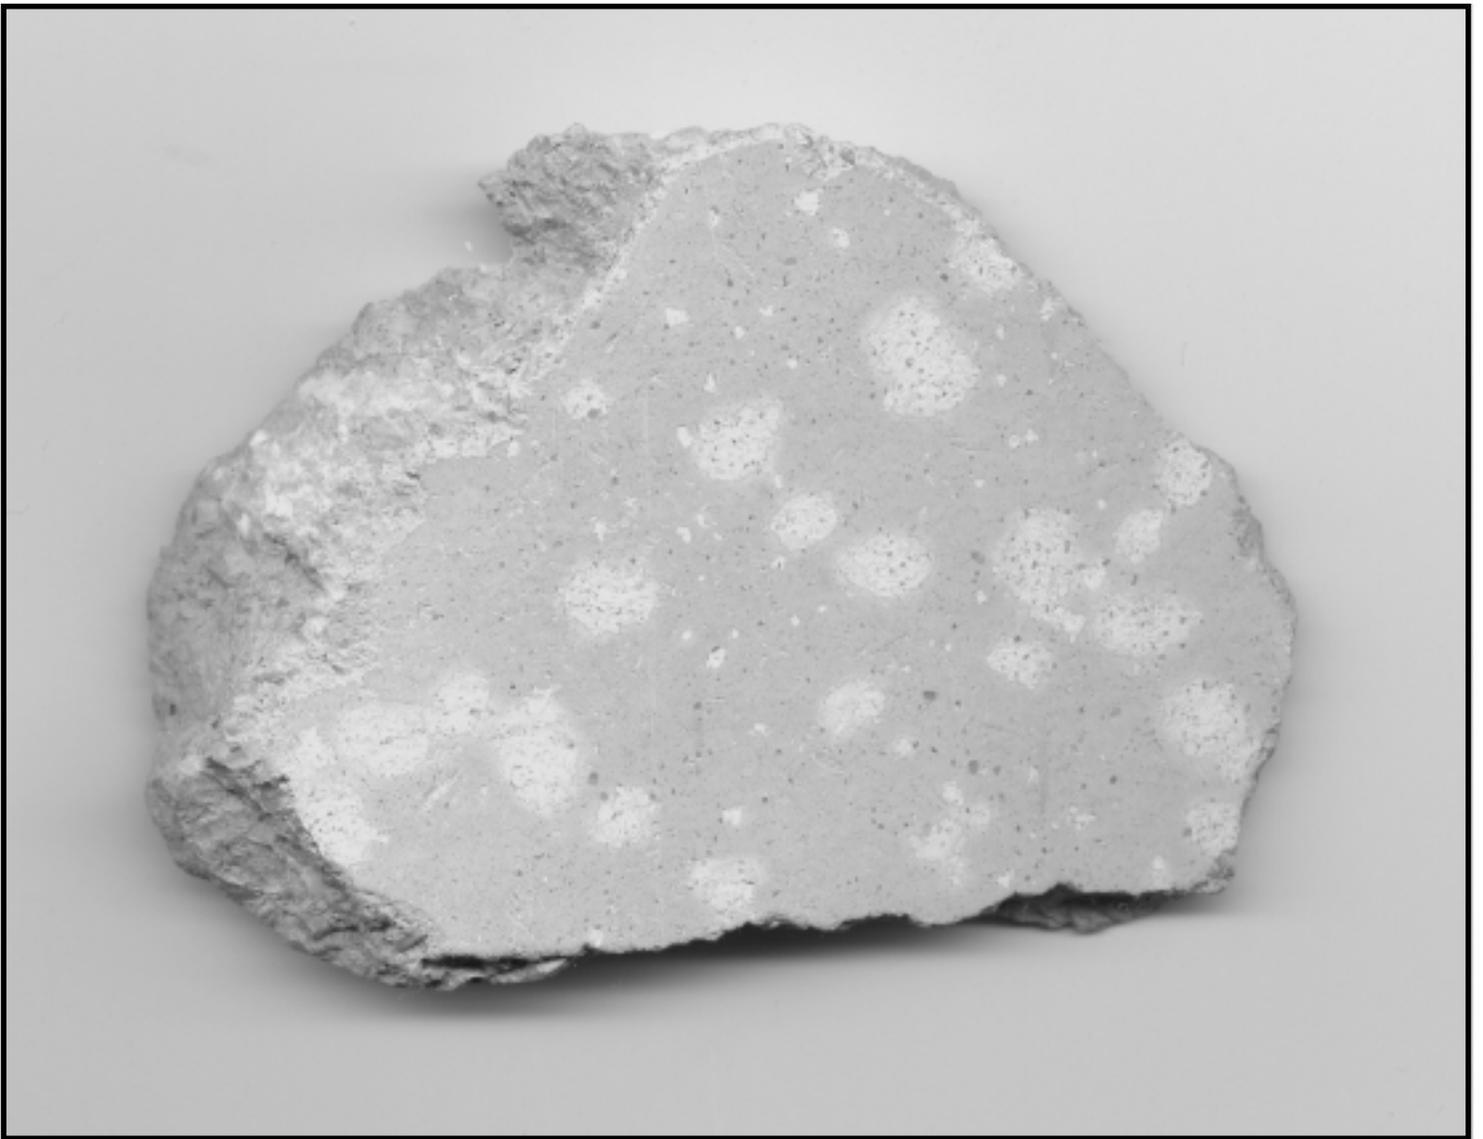
The onBalance team found that there is a direct connection between high calcium chloride levels — ranging from almost 2 percent up to over 4 percent in actual pool samples — and the presence of spot etching.

As part of the onBalance conclusions, it was determined that the primary characteristic of spot etched plaster is excess surface porosity, even in samples where subsurface porosity was acceptable.

This is an indication of both excess calcium chloride use and the use of water in finishing. Improperly timed trowel passes — where surface bleed water is trowelled back into the cement paste — can also cause excess surface porosity.

This plaster sample is spot etched on surface. For years, many blamed condition on “aggressive” water. But breakthrough research indicates that spot etching is caused during plaster preparation and application — not as result of water chemistry.

OnBalance is recommending the elimination of calcium chloride accelerators and the use of alternative accelerating chemicals, and advising plaster crews to minimize hard troweling and retempering during finishing operations.

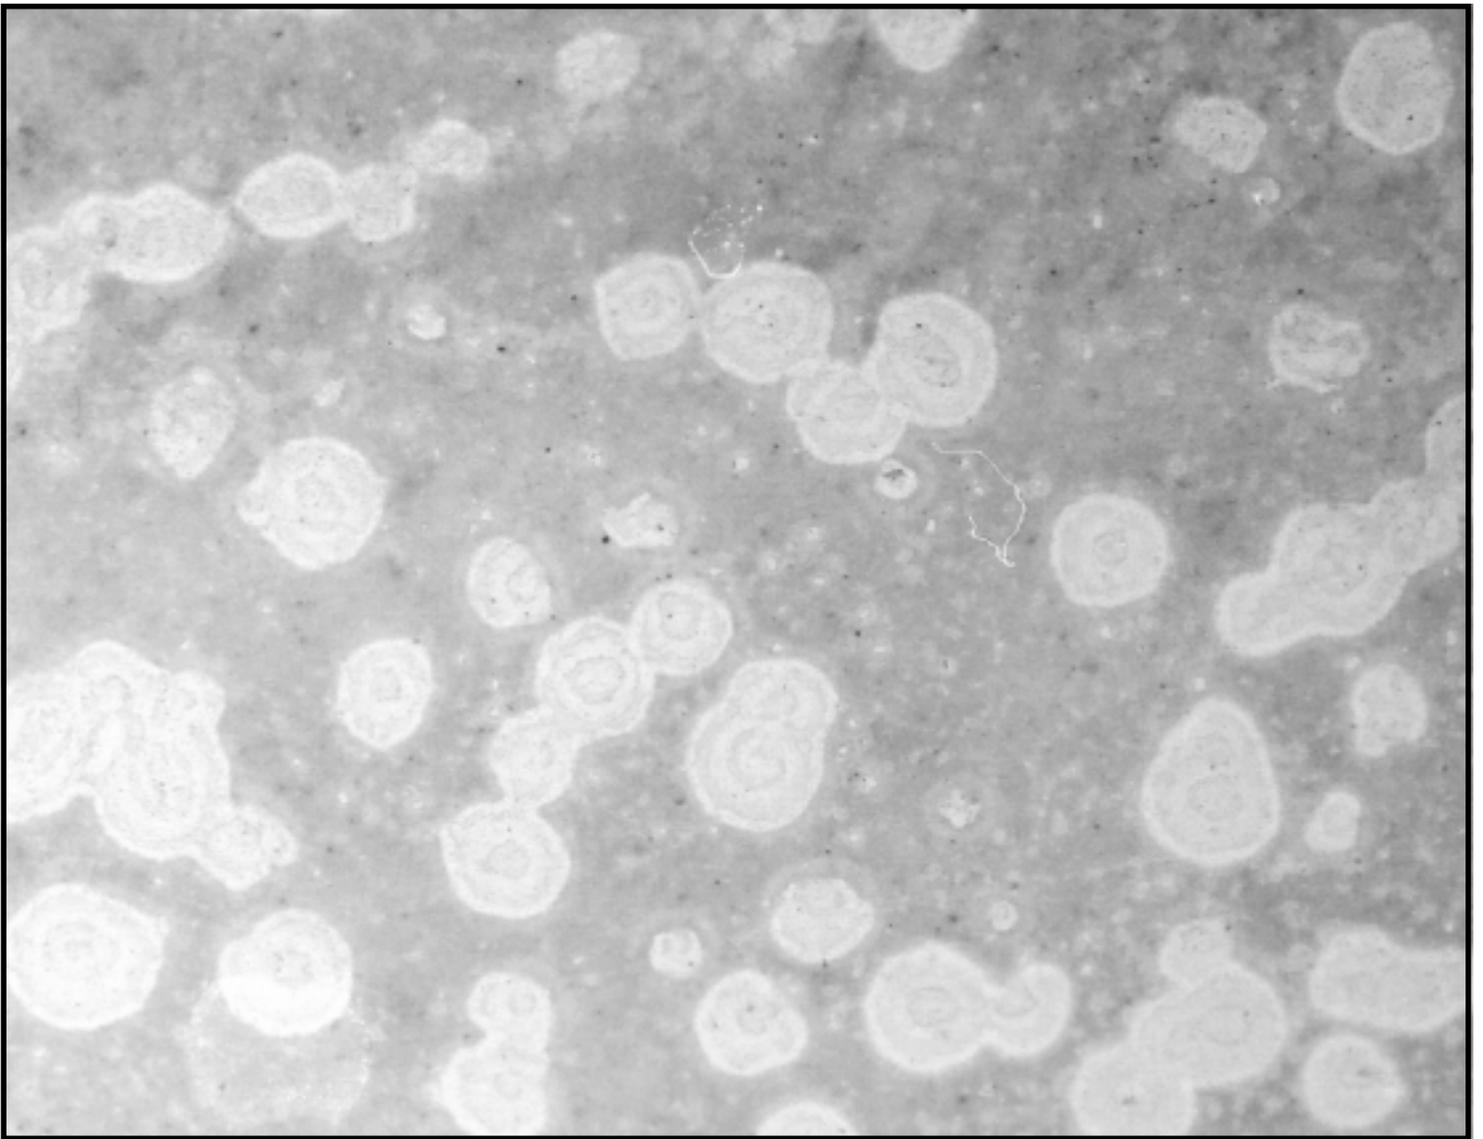
This photo of swimming pool wall reveals severe case of spot etching. It is hoped that new research will lay to rest “finger pointing” that often accompanies condition and will usher in new era of cooperation between plasterers and service techs.
