## **onBalance Case History #oB-00005E**

The (homeowner name) pool on (homeowner address) in Tracy California was built by Aqua Pool and Spa, and plastered by Burkett Pool Plastering. According to the records of Aqua Pools and Spas, the pool was built and plastered in September of 1998, and turned over to a service company, Aqua Chlor, who started the service on 9/2/98. On that first day of service, the service company already documented that the pool surface had “white spots and streaks throughout pool and spa – mottled.”

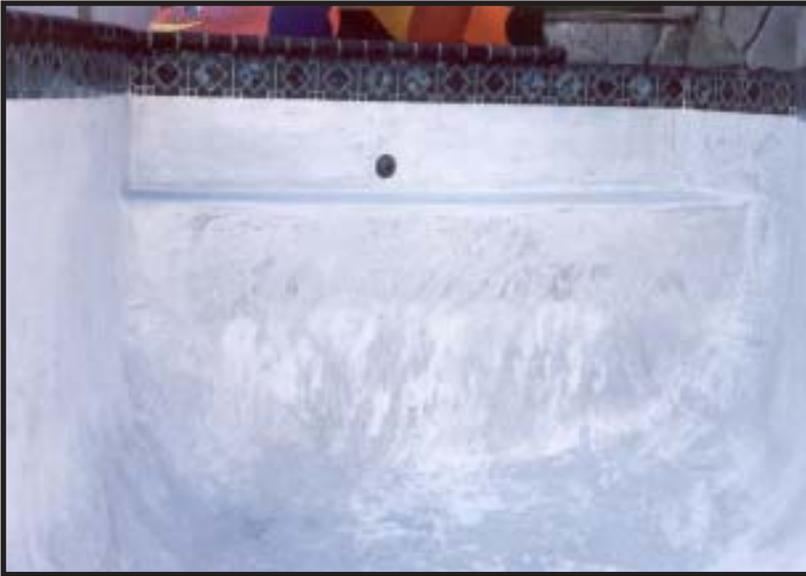
The grey plaster pool exhibits an extreme discoloration pattern, and the pattern coincides with fan patterns of discoloration, smeared plaster up onto the grout, driplines, etc. At these inspections, it was noted that the plaster surface was predominantly very smooth to the touch and to visual analysis.

**oB-00005Ea – Patterns  
on wall**

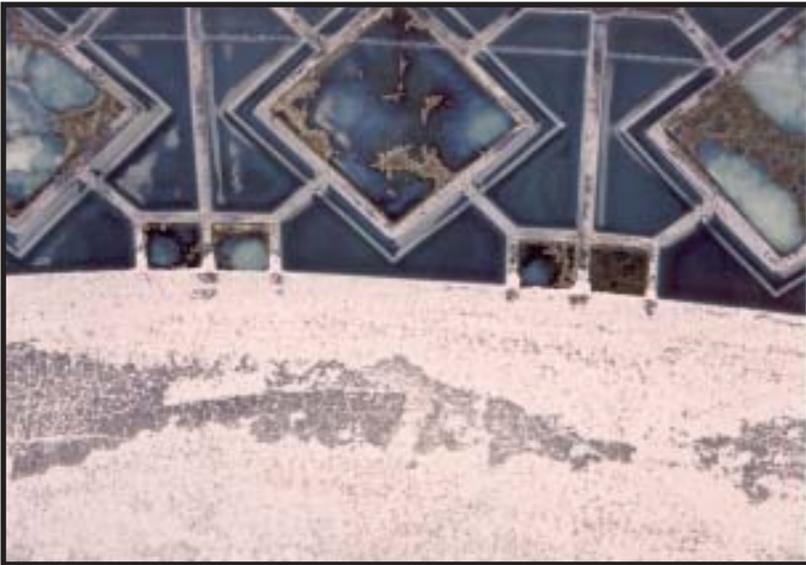
- The “discolored grout” mentioned by Beard and Smith is actually discolored plaster which was pulled up over the grout by the plastering crew, and not cleaned off (see attached photograph oB-00005Eb).
- onBalance did not observe the metal deterioration claimed by Beard and Smith. The glaring problem with their written observations is that, although they were provided with a list of plaster components by the plastering contractor (Burkett), they did not address the obvious admixture incompatibility, nor did they address why the plaster was already discolored a day after plastering, before the service company ever added chemicals to the pool. Smith also does not explain how plaster could simultaneously be “smooth to the touch” and also “extremely etched,” when the two conditions are usually considered mutually exclusive.

**oB-00005Eb – Tile  
grout with plaster  
pulled up from pool,  
calcium buildup above  
and below water line.  
Blotchy pattern on  
plaster.**

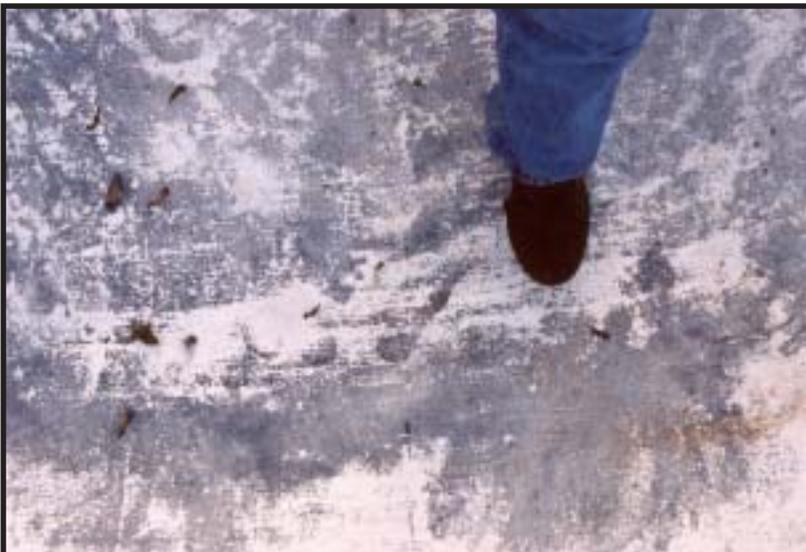
**oB-00005Ec – Footstep  
patterns and blotchy  
discolorations on floor**

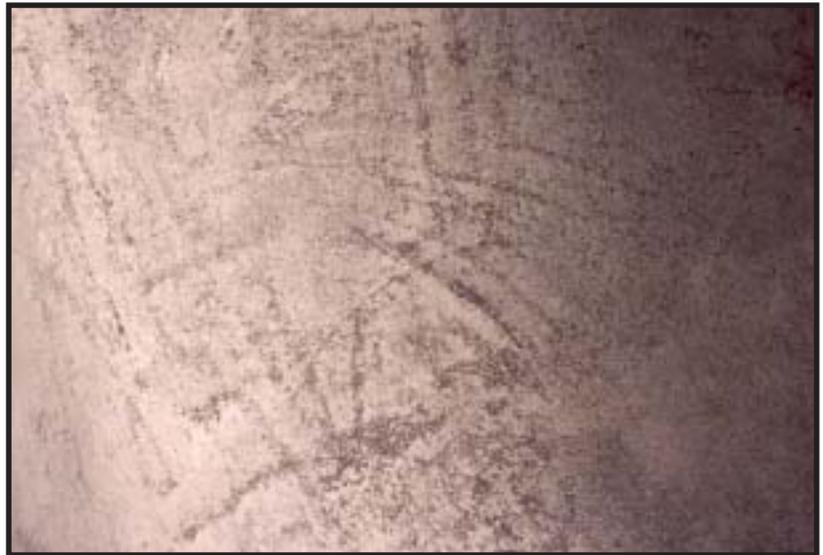
**oB-00005Ee – Crazeing on step face**

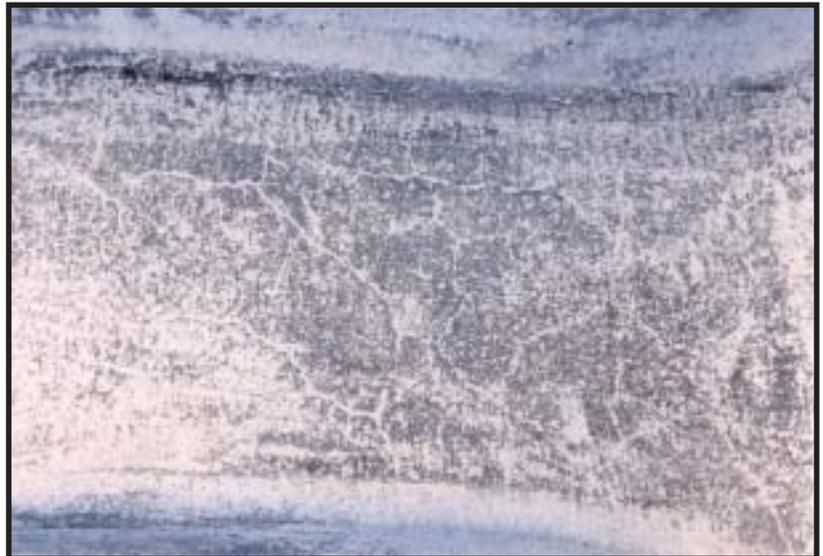
**oB-00005Ef – Trowel-pattern streaking on surface highlighted by discoloration**

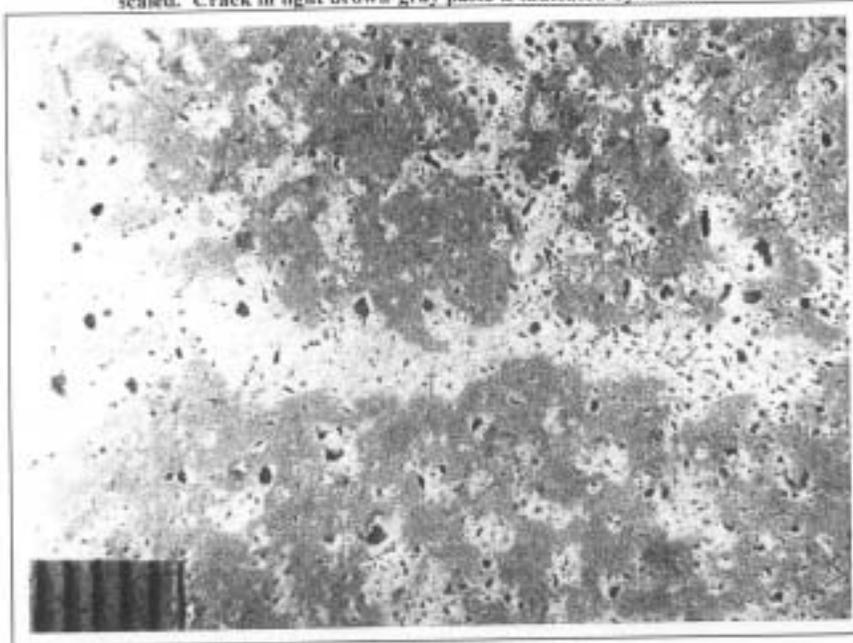
PHOTO NO. 3 - Shows light brown-gray very lightly scaled paste and medium gray paste that is not scaled. Crack in light brown-gray paste is indicated by arrows.

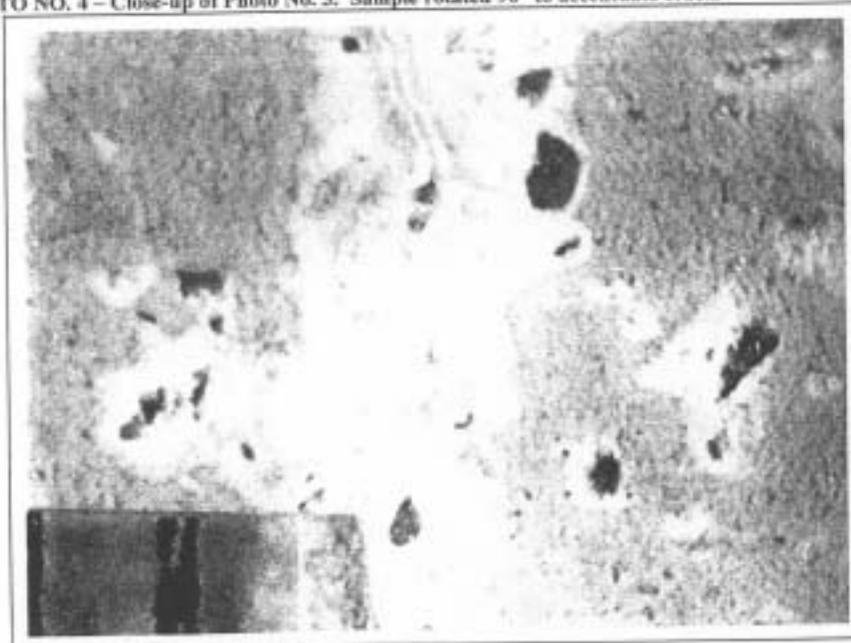
PHOTO NO. 4 - Close-up of Photo No. 3. Sample rotated 90° to accentuate crack.

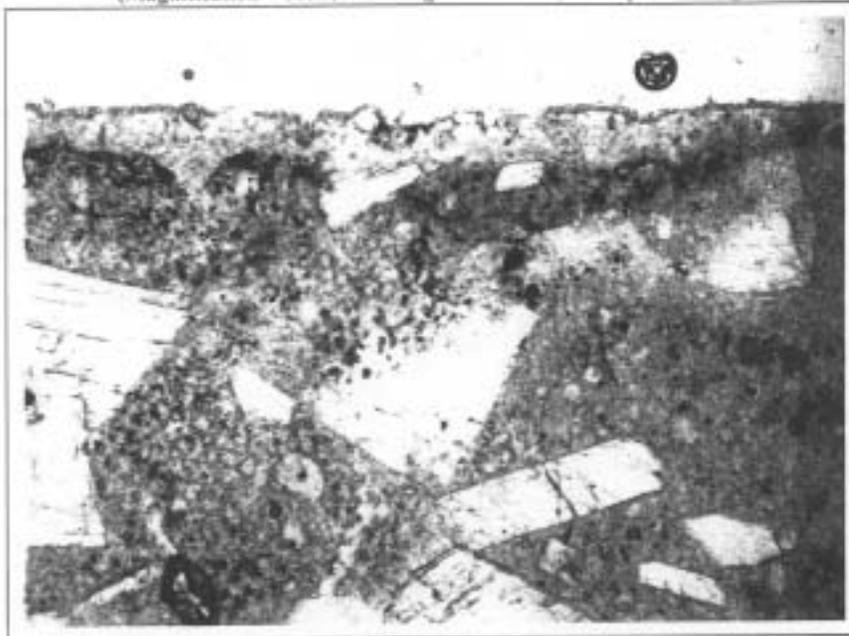
PHOTO NO. 7 - Close-up of Photo No. 5. Thin layer of secondary  $\text{CaCO}_3$  on exterior face (arrows).  
(Magnification = 100X, Field length = 0.72 mm, Plane polarized light)

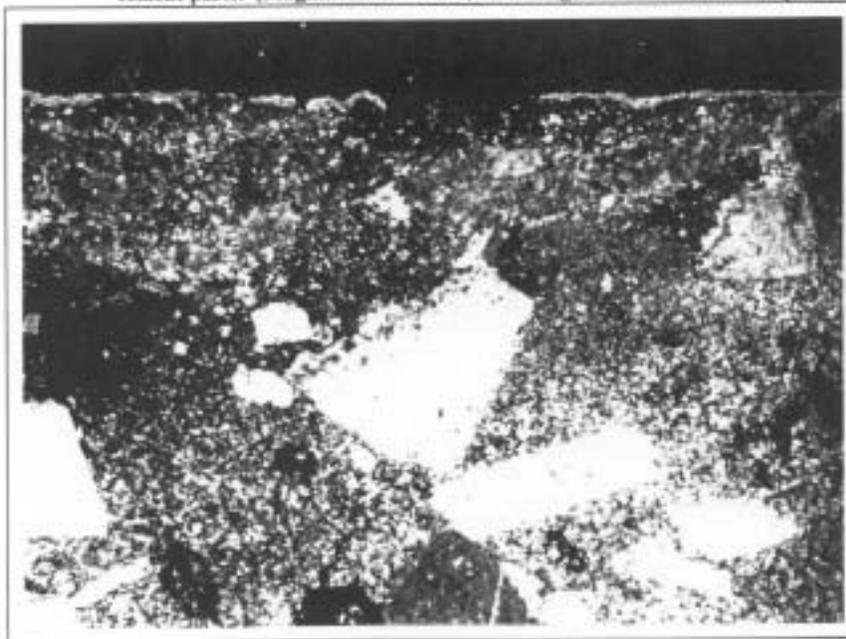
PHOTO NO. 8 - Same field as Photo No. 7 with crossed polars. Shows non-uniform carbonation of cement paste. (Magnification = 100X, Field length = 0.72 mm, Crossed polars)

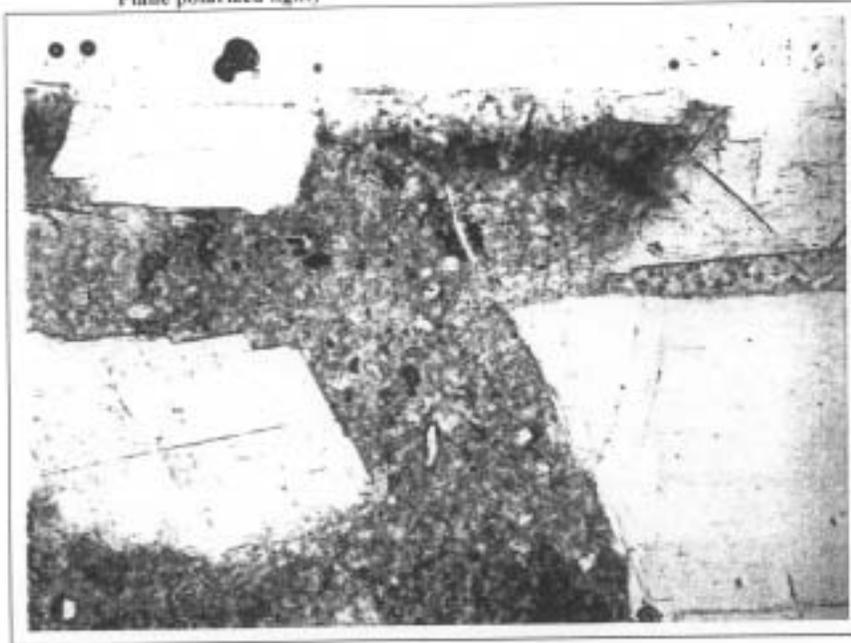
PHOTO NO. 9 - Unstained area of thin section similar to Photo No. 7. Shows very low amount of unhydrated white cement particles. (Magnification = 100X, Field length = 0.72 mm, Plane polarized light)

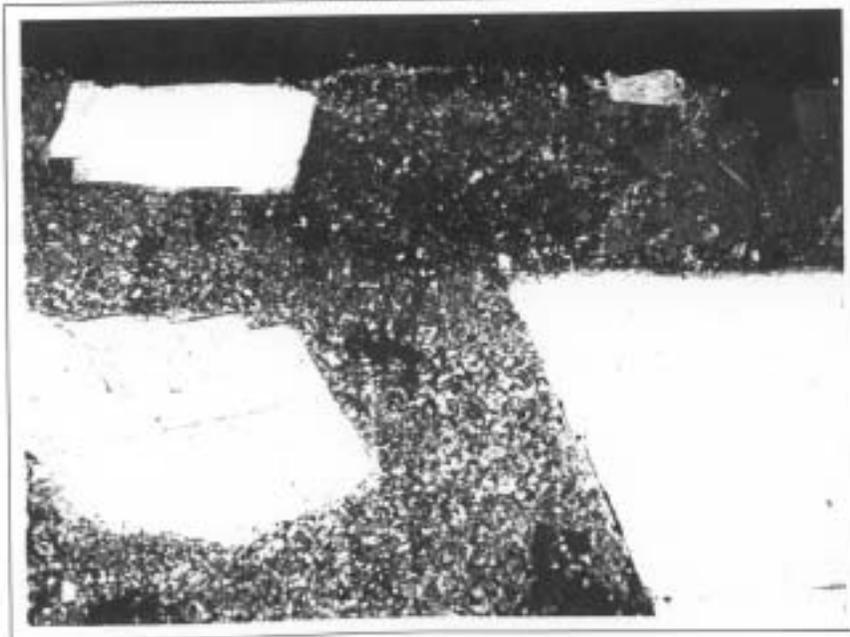
PHOTO NO. 10 - Same field as Photo No. 9 with crossed polars shows non-uniform paste carbonation. (Magnification = 100X, Field length = 0.72 mm, Crossed polars)

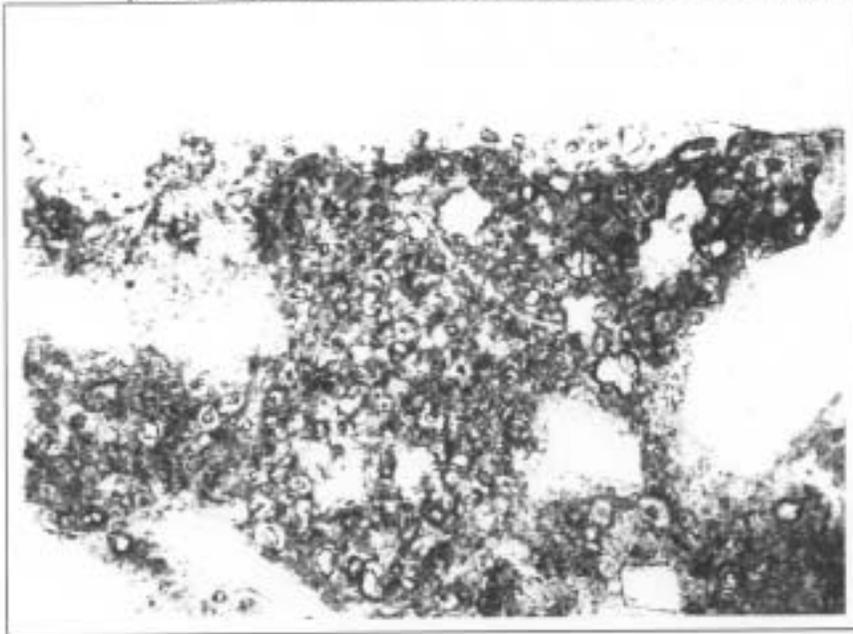
PHOTO NO. 11 – Unstained area shows a moderate amount of unhydrated white cement particles in paste (arrows). (Magnification = 100X, Field length = 0.72 mm, Plane polarized light)

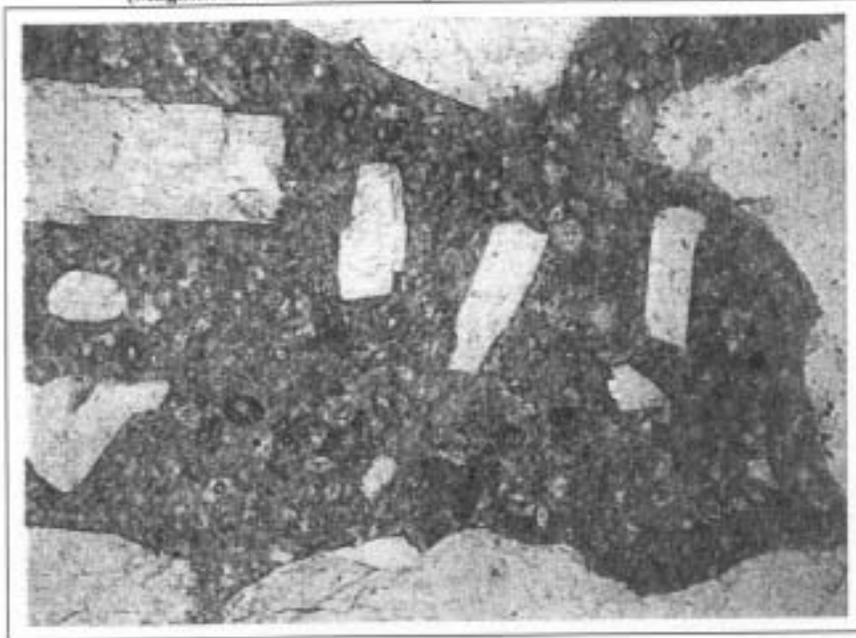
PHOTO NO. 13 – Stained section of paste below exterior face adjacent to shotcrete layer. Note strong pink colored paste as compared to stained section from Photo Nos. 5 and 7.  
(Magnification = 40X, Field length = 1.8 mm, Plane polarized light)

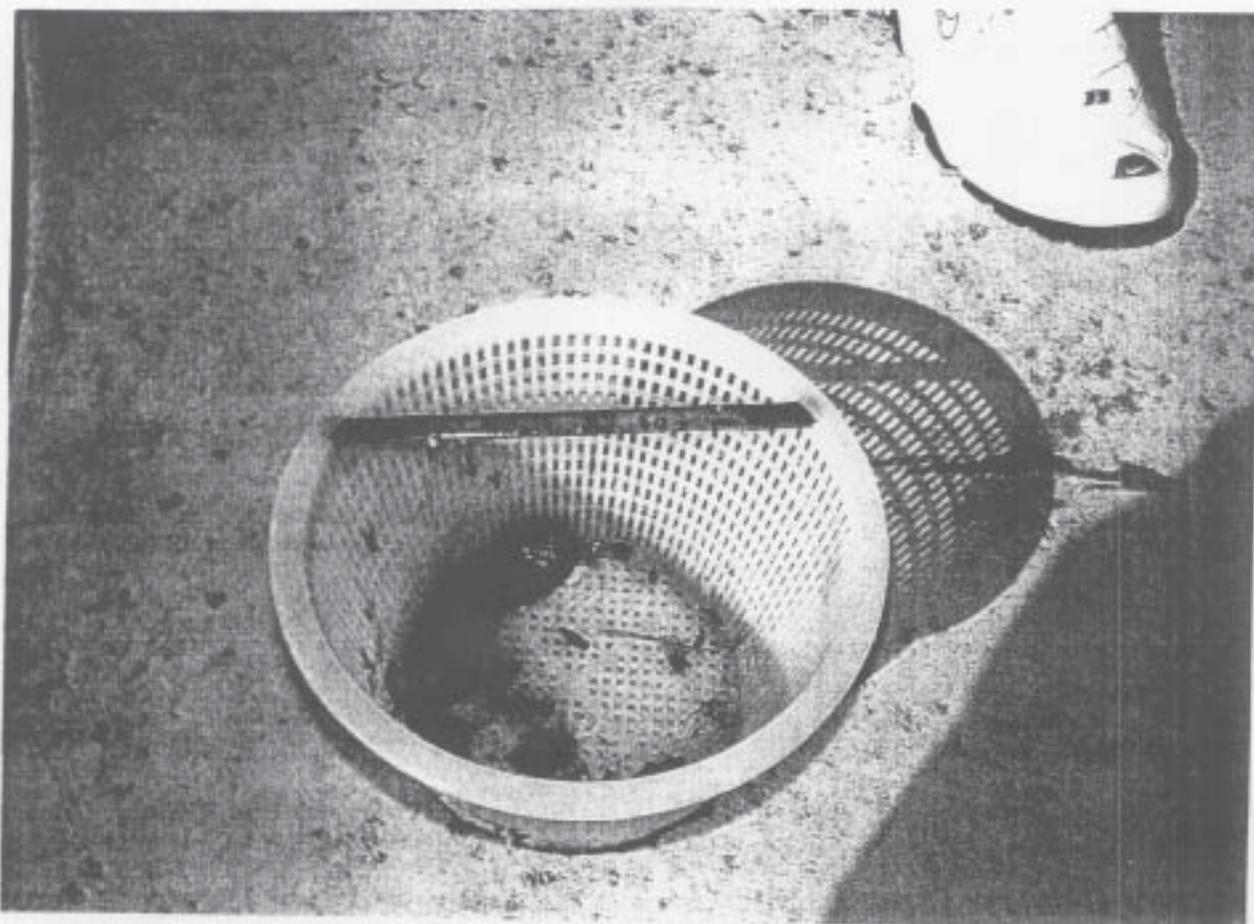
DESCRIPTION: Corroded copper in skimmer basket
