Case History
#oB-00015

Re: onBalance Project oB-00015 (Kennett)

You engaged onBalance to diagnose the cause(s) for discolorations on the surface of the swimming pool plaster located at 14637 N. 55th Street in Phoenix Arizona, at the residence of John and Kitty Kennett.

**EVALUATION OF SURFACE DISCOLORATION
SWIMMING POOL PLASTER**

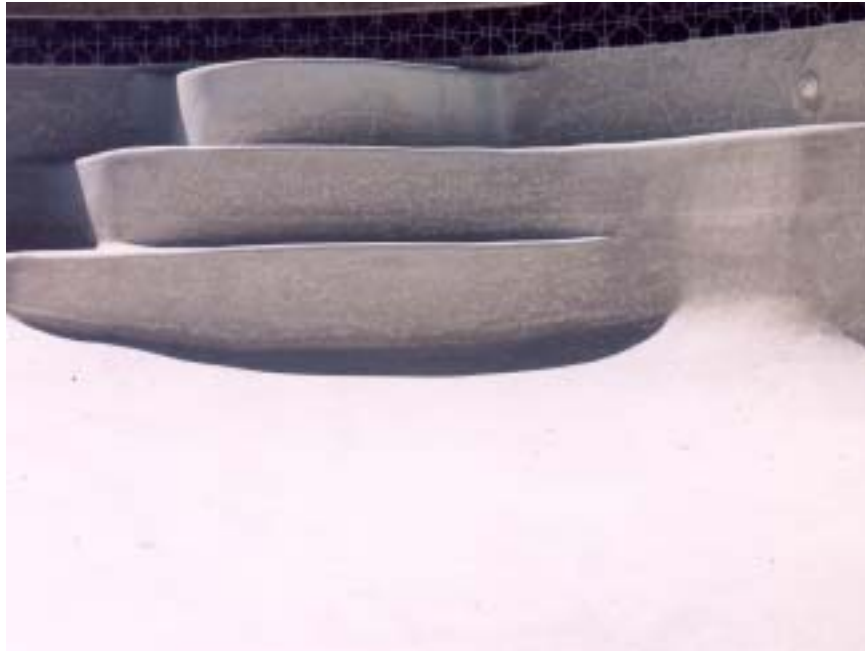
Figure 1 – Pool Steps

The pool exhibits a spotted discoloration pattern, and the spotted areas are highlighted with copper deposits (see Figures 1, 2, and 3). The pool also exhibits fan patterns of discoloration (Figures 4 and 5) and drip lines (Figure 6).

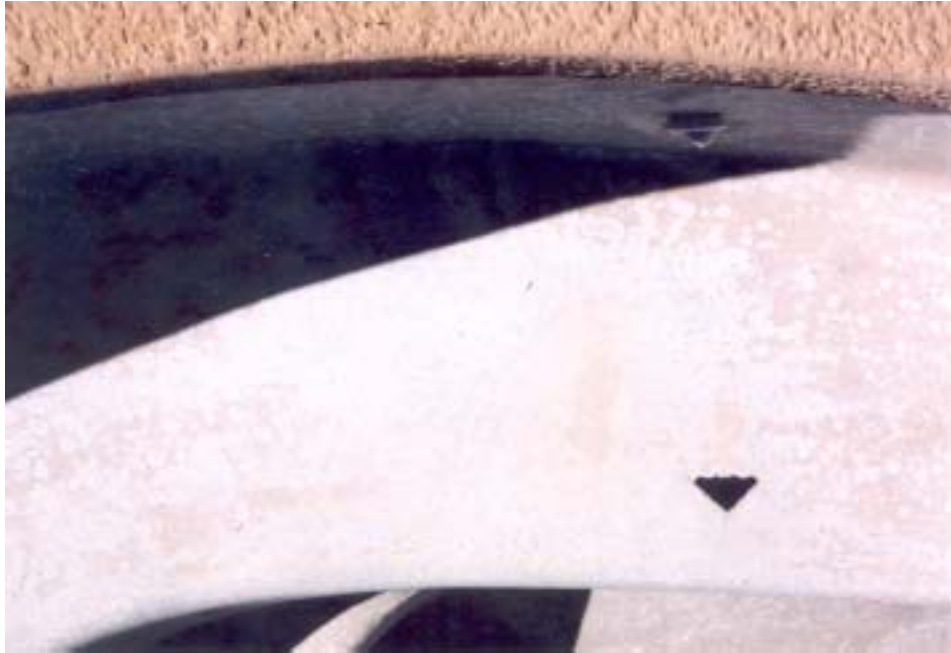
Figure 7 – Step under return

The distribution of the spots is relatively random, except for a concentration of affected surface under a shallow-end water return (Figure 7) and patterning on the pool walls where "fans" of spots indicate the influence of trowel passes in the spot distribution.

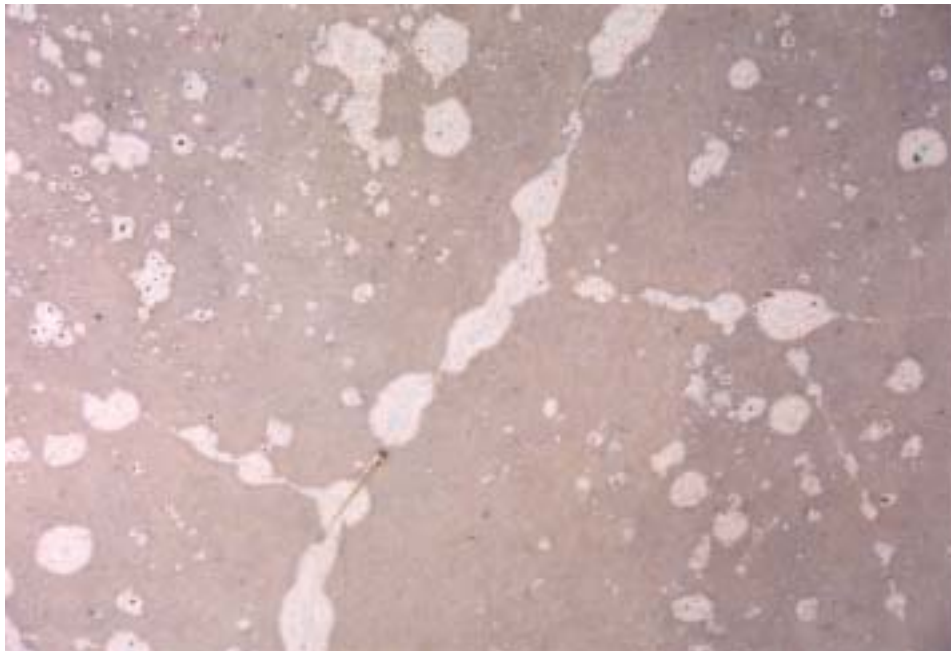
Figure 8 – Cracks

Photographs were taken of the pool. The photographs document the spotting, the distribution of the spots, driplines, fan patterning, and the macrostructural cracking (Figure 8).

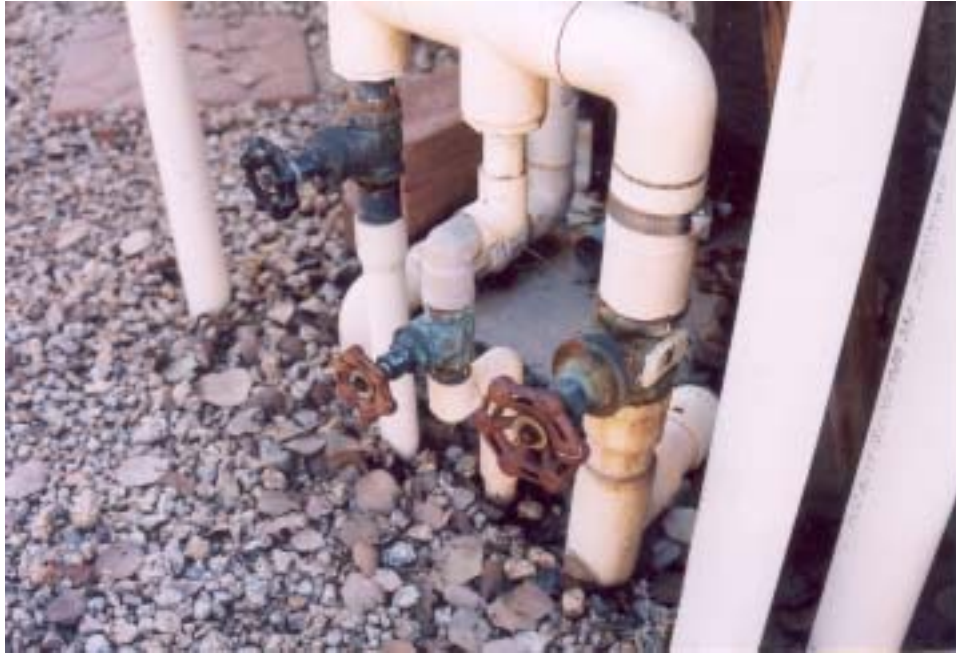
Figure 9 – Brass Fittings

Pool and tap water was sampled for analysis. Trace levels of dissolved copper were detected in the source water, which could account for some of the copper deposited on the pool surface. Old brass fittings plumbed into galvanized iron pipe is likely the source of additional copper in the pool water and on the most porous sections of the pool surface (Figure 9).

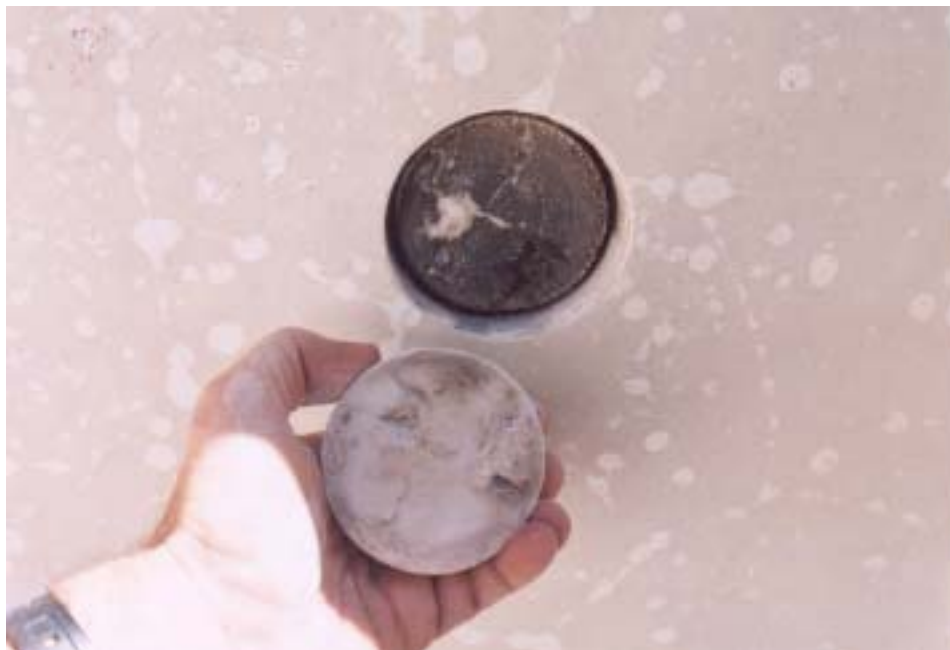
Figure 14 – Bond Failure

Photography – The pool was core sampled, and the cores were photographed both *in situ* and in the lab (see Figures 10 – 13). During the coring, it was noted that there is a total bond failure between the pool plaster and the gunite substrate in some areas of the pool (see Figure 14).

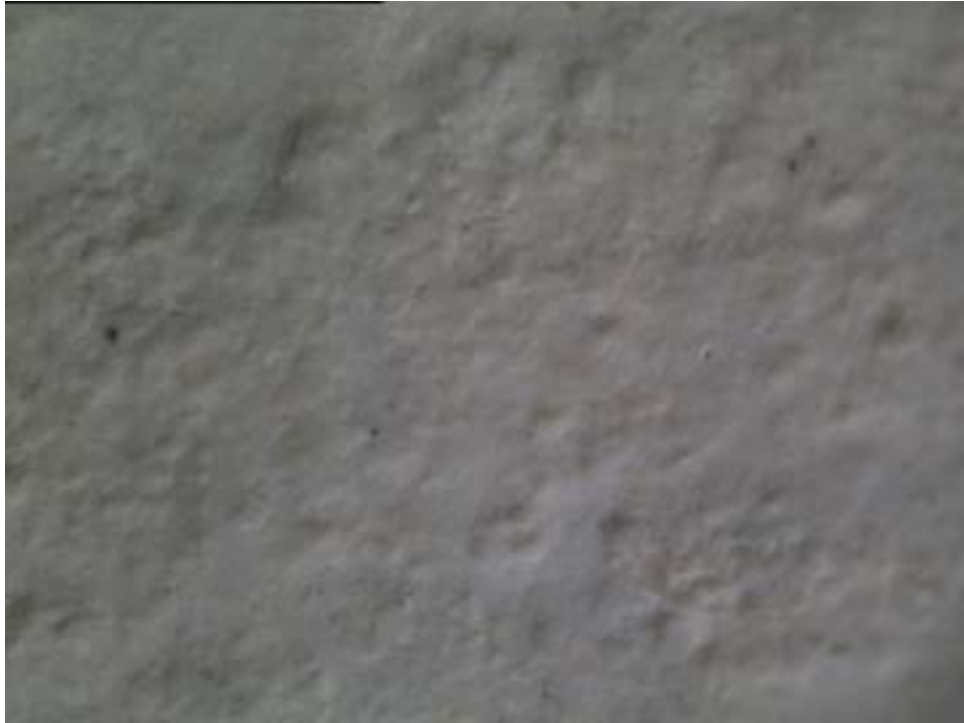
Figure 16 – Aggregate Exposure of Kennett Pool Surface

Photomicrography – The surface of a core sample was photographed at 40X magnification, with care taken to document the level of surface cement paste erosion as evidenced by the exposure of aggregate (sand) at surface (see Figures 15 and 16).

The pool has not undergone an aggressive chemical attack. None of the accepted hallmarks of aggressive attack (such as surface cement paste dissolution and etching of the surface-exposed aggregate) are evident. This is consistent with the chemical history documentation provided onBalance and with the water analysis undertaken by onBalance. The effect under the step return is best explained by the fact that the return water flow was pointed directly onto the fresh plaster from the time the pool was freshly filled until months later. This impingement on fresh plaster will cause surface erosion.

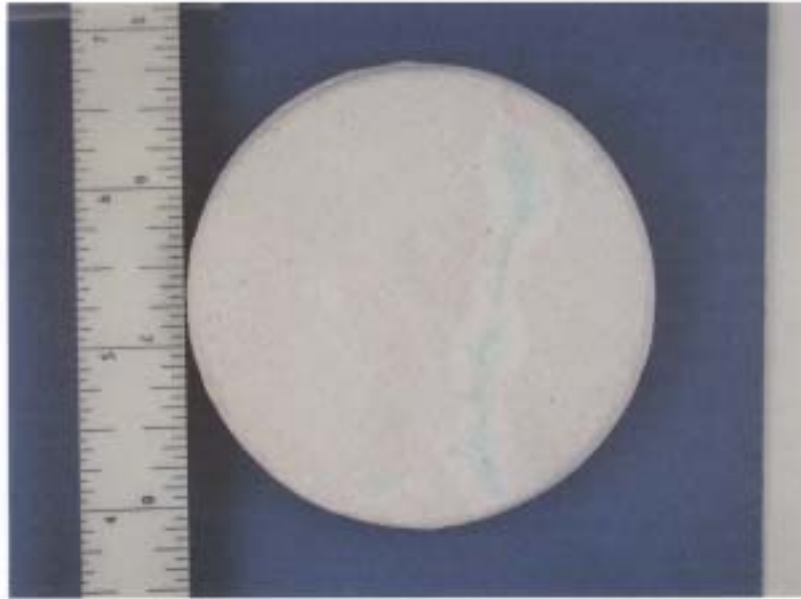
The sample was a small core of plaster only, shown in Figure 1. Figure 2 shows the plaster core with oblique lighting. No concrete, from the pool substrate, was observed on the opposite side (not shown), indicative of plaster delamination from the shotcrete substrate.

Photographic images are shown in figures 1 and 2. Stereo optical images are presented in figures 3, 4 and 5. Figures 1 and 2 show a line of "spot etching" following the length of a crack running along one side of the core.

Evidence of re-tempering on the surface is not observed in figure 1 and 2; the paste surface is relatively smooth. Figure 2 shows the sample in oblique lighting; relief due to re-tempering is not evident. Previous studies of samples obtained by OnBalance (e.g. report date 7/13/2001) have documented that re-tempering relief (an over-trowelled surface) directly corresponded to "spot etching".

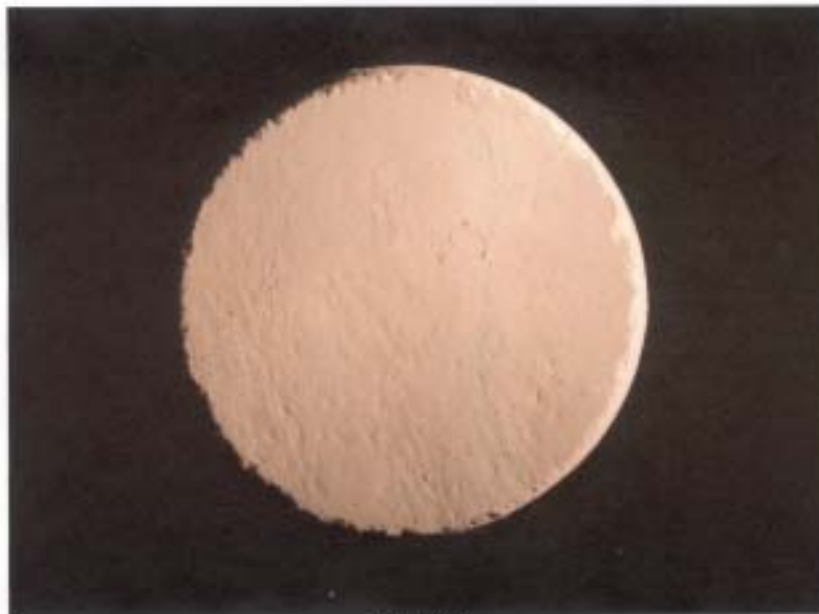
Figure 2.

Relief is observed, in figure 2, decorating the length of the crack due to efflorescence, indicative of a calcium rich material. From our discussions, this phenomenon seems to be generally termed nodular growth in the swimming pool industry. A green discoloration is observed also decorating the crack. Figures 3, 4 and 5 show higher magnifications of the efflorescence. The stereo optical images do not show evidence of "disrupted" paste indicative of an aggressive solution (surface attack due to acidic water conditions). This surface phenomenon is exemplified in a previous study (report date 2/6/02) where eight plaster coupons were subjected to various curing regimes and acidic water conditions (by OnBalance).

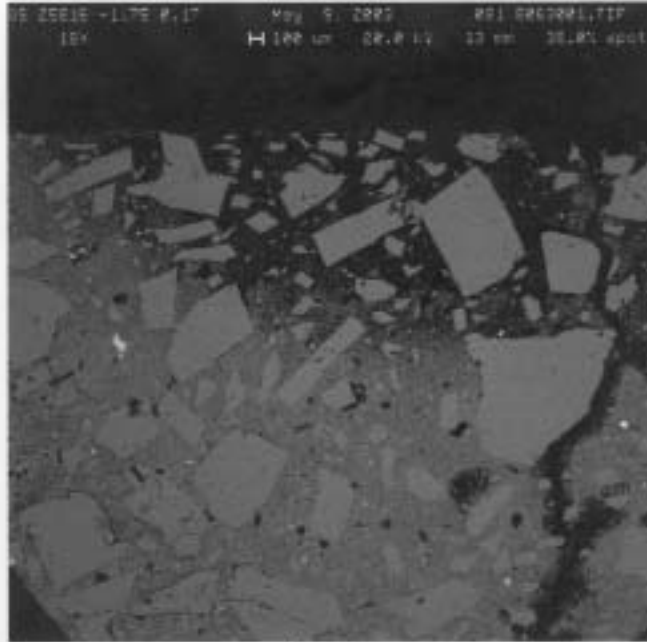
Figure 6.

BSE micrograph images of the cross-sectioned sample are presented in figures 6 through 17. Figure 6 shows an affected ("spot etched") region. As observed in many previous "spot etched" swimming pool plaster samples, the region consists of a calcium rich layer directly adjacent to the swimming pool water followed by a elliptical region of reduced calcium content (and higher silicon content). This highly siliceous region of increased porosity is indicative of the "spot etched" effect. These effects are documented in figures 6, 8, 9 and 11.

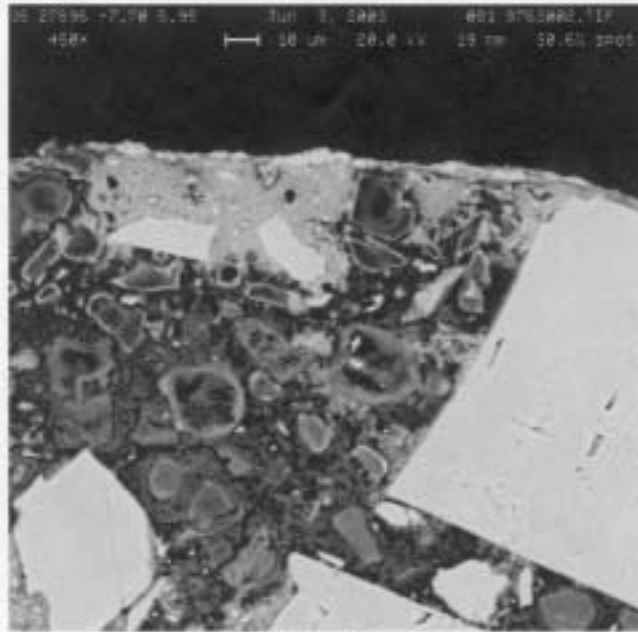
Figure 7.

Figures 7, 14 and 15 show cracking throughout the paste. Figure 7 shows a shrinkage crack pattern in a region away from the affected region and is typical of the general paste structure. The implication is that the crack pattern predates the affected region. Figures 14 and 15 are high magnification images taken of the cross-section along the crack shown in the stereo optical images. The images show that a calcium rich phase, indicative of calcium hydroxide decorates the crack. The morphology of this calcium hydroxide matches the structure of the crack, confirming that the calcium hydroxide formed after the crack had formed. The images also show a porous highly siliceous region decorating the crack.

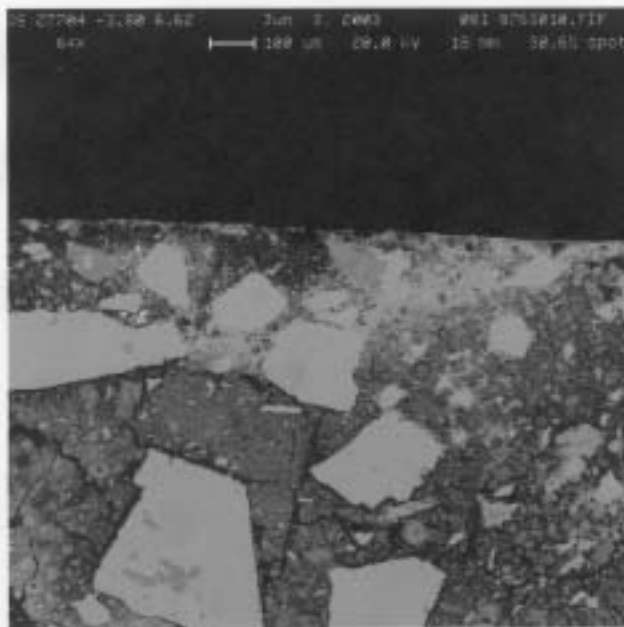
Figure 10.

Figure 10,12 and 13 show depositions of ettringite, a calcium aluminosulfate hydrate compound. Ettringite depositions are observed along cracks and in highly porous regions, indicating the depositions are formed during the paste reconstruction occurring during the movement of calcium through the paste. The ettringite deposits have thus formed after the formation of the highly porous regions.

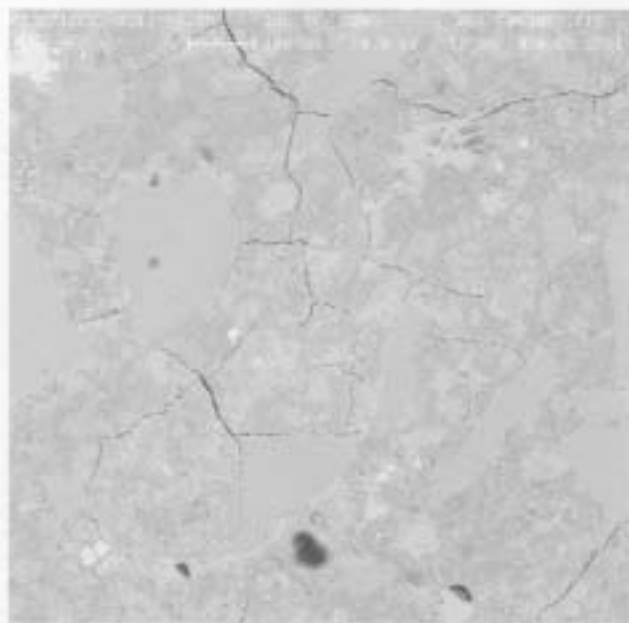
Figure 16.

Figures 16 and 17 show a high content of chloride is present in the paste. The chloride concentration is high enough that not only are Freidel salts present, but also increased chloride content is observed in calcium silicate hydrates.

The chloride content in the paste (observed in the SEM) indicates that calcium chloride has been added to the plaster at a concentration greater than 2 Wt%. This addition has resulted in extensive shrinkage cracking throughout the plaster paste. This cracking also appears to predate the formation of the affected region, highly porous paste follows the crack and calcium rich material has moved from the porous regions into the crack.

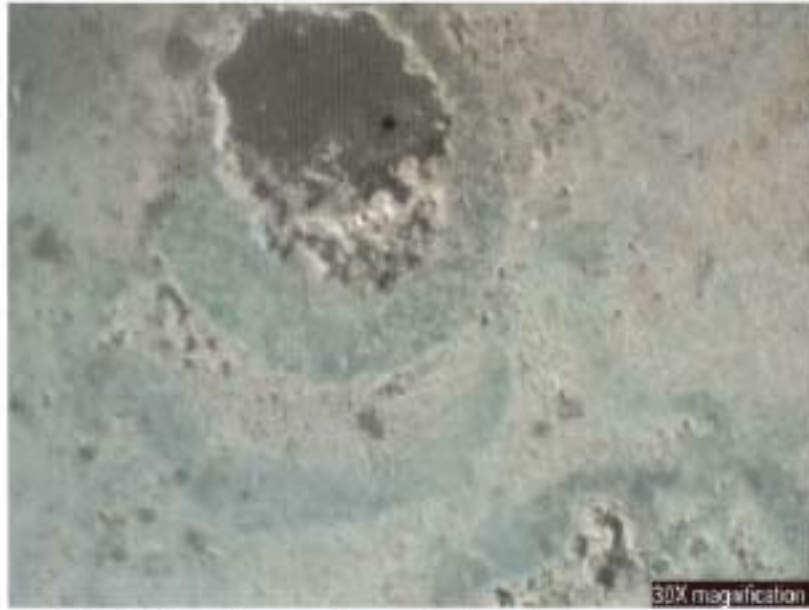
- Small bright white spots with and without greenish gray rings occur over shallowly embedded chips of marble aggregate (Figs. 1 and 2). These spots consist of soft and porous paste and are slightly depressed below the troweled surface. In the areas studied, smaller spots are found above smaller aggregates and larger spots with green rings (sometimes multiple rings) are present above larger aggregate particles. The outer surface of the marble does not exhibit evidence of dissolution or etching. The marble contains variable but small amounts of pyrite (iron sulfide) and rust stains are sometimes present around exposed pyrite crystals. It is not known whether the presence of pyrite is related to the development of the observed discoloration.

Fig. 1 Stereomicroscope image showing soft spots over marble aggregates and discoloration of the troweled surface of the plaster.

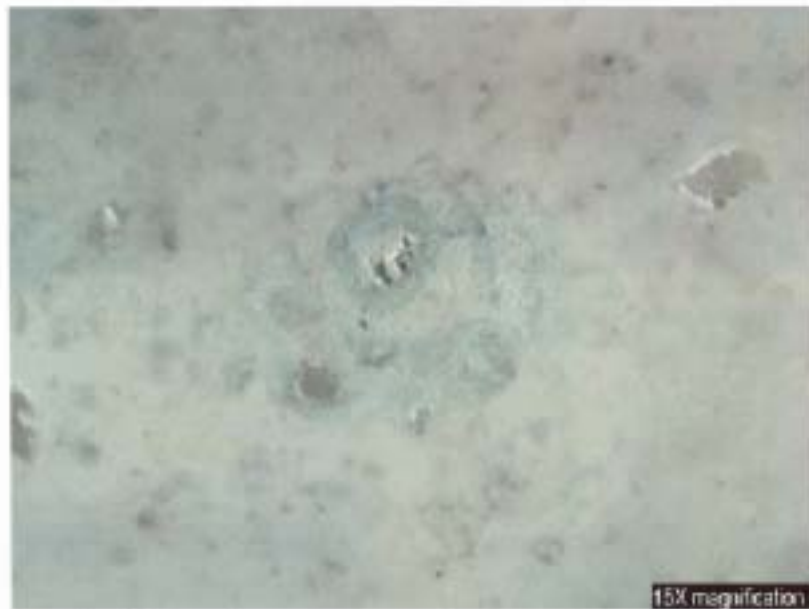
Fig. 2 Stereomicroscope photograph showing soft spots and discoloration on the troweled surface of the plaster.

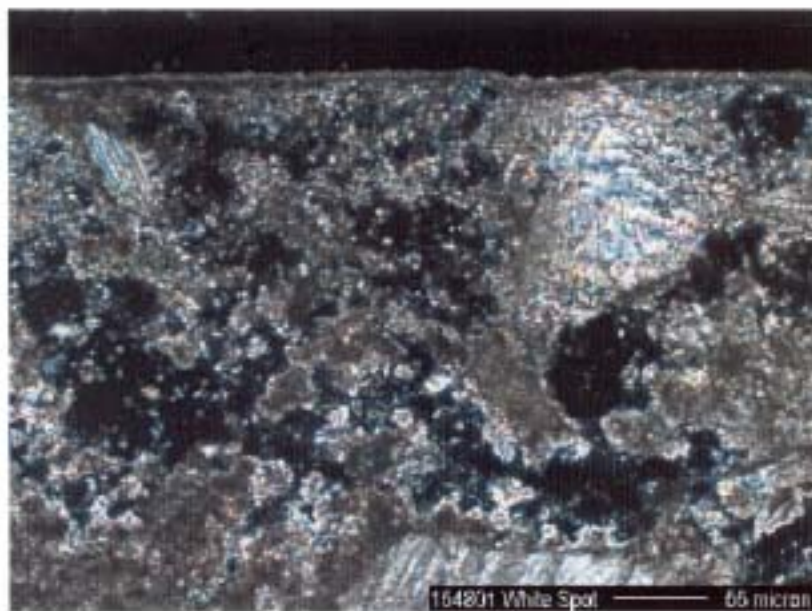
Fig. 3 Thin-section micrograph showing lacy texture of paste in the soft white spots at the troweled surface of the plaster. Dark areas are leached paste. Cross-polarized light.
