# An Update on the Cause of Swimming Pool Plaster Efflorescence (Calcium Nodules)

Que Hales, Doug Latta and Kim Skinner - *onBalance*

*Swimming pool plaster samples exhibiting calcium nodule growths have been analyzed by cement petrographers, and the findings are consistent with the model proposed by onBalance in a 1998 JSPSI article.*

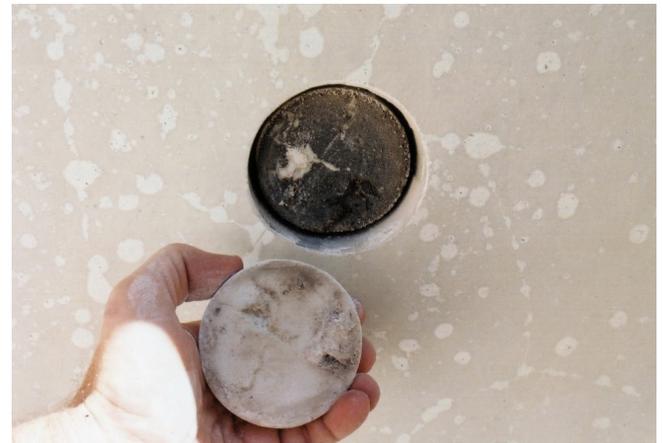
**Figure oB-00015a – Bond Failure and Cavity Behind Crack and Nodule**

This pool failed primarily by being extensively soft spotted. However, there were also some areas where nodule formation occurred. In one such area, a core sample was removed to acquire the nodule and we found complete bond failure between the gunite substrate and the plaster layer (see Figure oB-00015a). Hairline cracking occurred in the plaster, allowing water to penetrate between the plaster and the gunite, and a nodule formed along the exterior crack line. A three-inch core was removed from the plaster, which including the nodule (see Figure oB-00015b). This core was sent to Dr. Boyd Clark, at the time a Senior Materials Scientist and petrographer at the RJ Lee Group (RJLG). An additional sample of the plaster (with soft spotting only, no nodule) was sent to Laura Powers, at the time a petrographer and Principal Microscopist at Construction Technology Laboratories (CTL), the subsidiary lab of the Portland Cement Association (PCA) for a second opinion.

*No concrete, from the pool substrate, was observed on the opposite side (not shown), indicative of plaster delamination from the shotcrete substrate. [RJLG p. 1]*

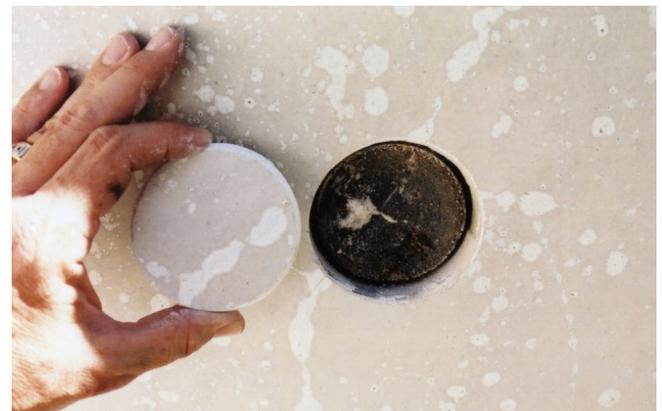
**Figure oB-00015b – Front of Core with Crack and Nodule Following Crack**

*Relief is observed, in figure 2, decorating the length of the crack due to efflorescence, indicative of a calcium rich material. From our discussions, this phenomenon seems to be generally termed nodular growth in the swimming pool industry. [RJLG p. 2]*

*The stereo optical images do not show evidence of “disrupted” paste indicative of an aggressive solution (surface attack due to acidic water conditions.) [RJLG p. 2]*

*The chloride content in the paste (observed in the SEM) indicates that calcium chloride has been added to the plaster at a concentration greater than 2 Wt.%. [RJLG p. 3]*

*This addition has resulted in extensive shrinkage cracking throughout the plaster paste. This cracking also appears to predate the formation of the affected region, highly porous paste follows the crack and calcium rich material has moved from the porous regions into the crack. [RJLG p. 3]*

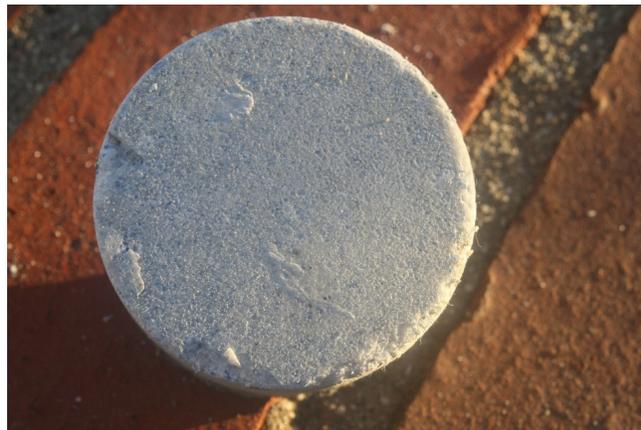
**Figure oB-00045 – Front of Core with Craze Nodules Following Cracks**

This pool failed by accumulating hundreds of small white calcium nodules on craze lines throughout the pool and spa plaster surface after about a year from plastering. The pool was drained, polished (wet sanded) and re-filled multiple times. Each time new nodules formed on the craze cracks.

A sample of the plaster with a nodule was cored (see Figure oB-00045) and sent to Laura Powers, at the time an Associate Principal Microscopist at Wiss, Janney, Elstner Associates.

*...the plaster is tightly adhered to the shotcrete. [p. 2].*

*If the assumed proportions of cement and sand are 1 part to 1-1/2 parts, the percentage of calcium chloride dihydrate by mass of cement is 4.81 at a water-cement ratio of 0.5 and 4.47 percent at a water-cement ratio of 0.3. [p. 2]*

*The elongated white nodule appears to be an extrusion at the outside end of a low-angle (approximately 10 degrees) crack that intersects the exterior surface of the plaster (Figure 4)... The crack passes around crushed marble aggregate particles suggesting that it formed fairly early, probably during finishing operations. [p. 2]*

*The general characteristics of the crack suggest that it was caused by finishing operations. [p. 3]*

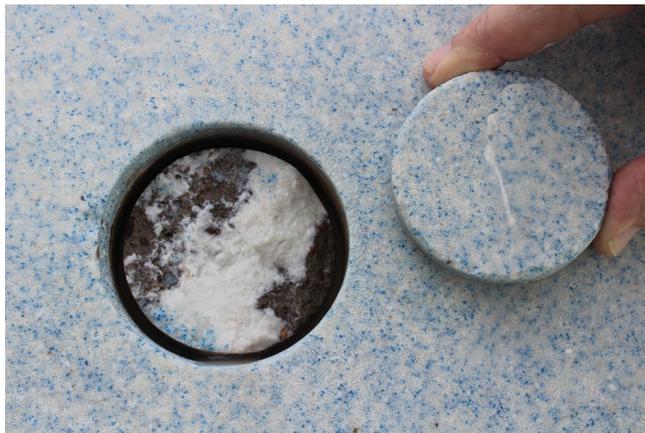
**Figure oB-00058 – Core 4 with Nodule Following Crack and Bond Failure**

This pool plaster failed in a way that was visually similar to the previous pool, but which actually had bond failure similar to the first (Figure oB-00058). The plaster had been repeatedly re-polished (wet sanded), yet small calcium nodules on craze lines repeatedly reappeared.

*Remnants of an older white plaster (Figs. 5 and 6) and patches of gray concrete substrate are adhered to the bottom surface of Core 2 Floor and to the back surface of the Core 4 Wall. [p. 2]*

*The delamination crack may be an artifact of troweling operations. Microcracks are*

common in the surface region of Core 4 Wall (Fig. 14). The cause of microcracking is not apparent. Possible causes include finishing and curing operations. [p. 3]

The chloride content in the bulk paste is listed at 0.768 weight percent [p. 3], which is 4.4% as calcium chloride dihydrate to cement. Again, this is more than double the commonly accepted maximum dose.

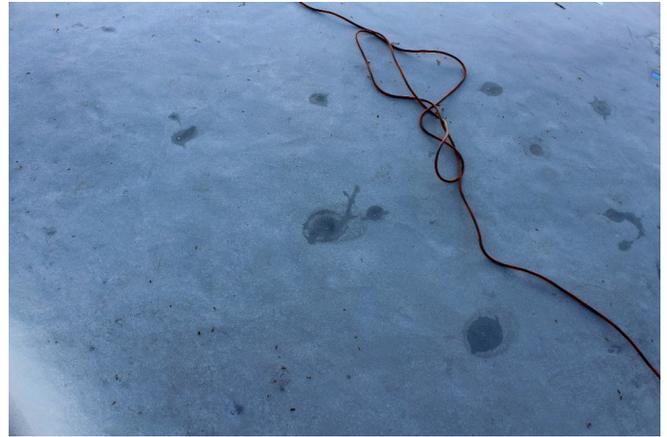
**Figure oB-00060a – Pool Floor with Nodules Over Cracks and Sub-Surface Trapped Water**

As a point of interest, although this pool has yet to be replastered or core sampled, it was covered with small nodules similar to the previous two pools. Again, the plastering contractor assumed that the nodules were craze nodules, and he was under the impression that craze nodules were the result of pool water maintenance failures. However,

when the pool was drained, it was found that each nodule was located on a small, almost invisible crack which led to a sub-surface reservoir of contained water. These, then, were bond-failure nodules and are being addressed by the contractor.

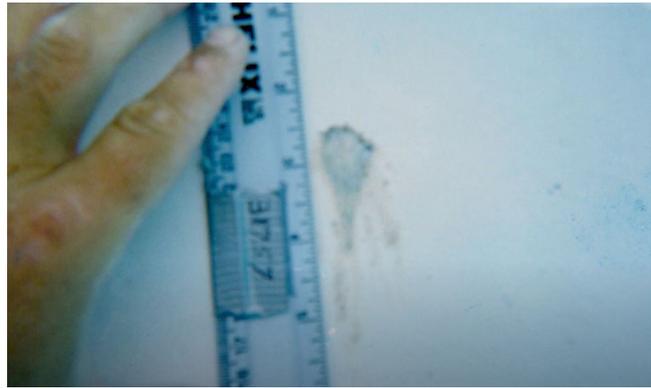
**Figure A – Screenshot From Garrett Video**

Photographs of this calcium nodule (see for example Figure A – Garrett) were used in Mr. Garrett’s pool industry presentations to insinuate that calcium nodules must be precipitated from dissolved calcium in the pool water, rather than from the pool plaster and/or cementitious substrate, since there was no pool plaster involved (see, for example, a video of Mr. Garrett making such claims here: <https://www.youtube.com/watch?v=4cY-oWNq-PKo>).

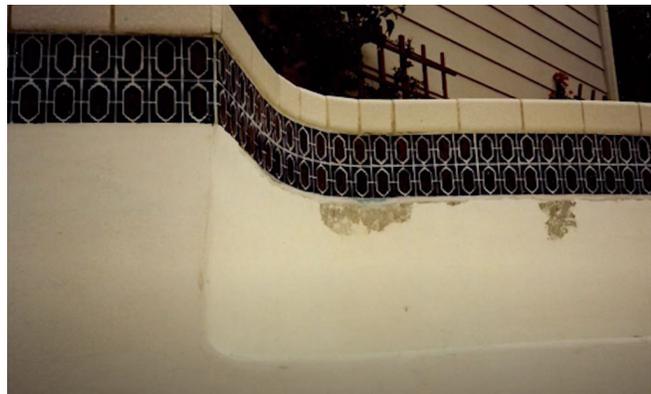
**Figure B – Screenshot From Garrett Video**

However, the lab analysis, dating previous to Mr. Garrett’s presentations, shows that the defective fiberglass coating (see Figure B – Garrett) was apparently compromised with a path, in this report referred to as a “pin hole,” through which water could penetrate to the previous plaster and/or the gunite substrate behind the fiberglass coating:

*There is some evidence of an actual pin hole through the surface to the plaster backing. [p. 1]*

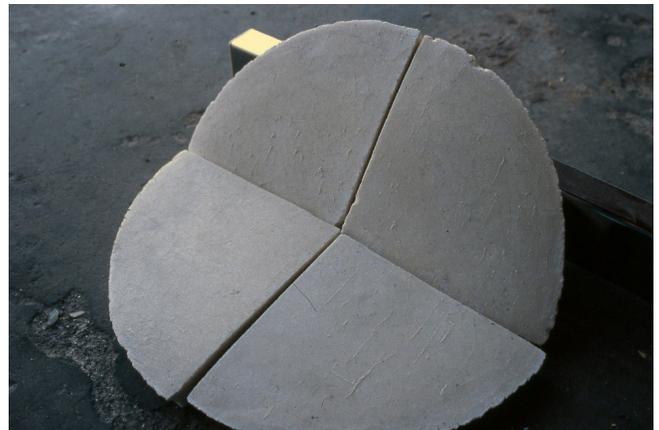
Figure oB-00042b – Nodules on Plaster Surface

*The nodule growth on the top surface of the coupons is calcium carbonate*  
Volume 6 Number 2 – Spring 2023

*Shrinkage cracking of the coupons and leaching of calcium from the paste was promoted by calcium chloride content, apparent from the distinctive map crack pattern developed in high (10 Wt. %) calcium chloride content standard plaster.*

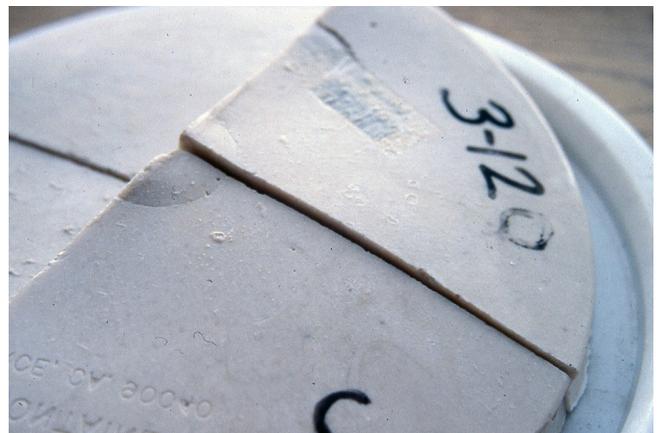
Figure oB-00042c – Absence of Nodules on Molded “Backside” of Plaster Surface

In 1999 the National Plasterers Council and the National Association of Gas Chlorinators collaborated on a project that involved creating 12” diameter pool plaster coupons for experimentation (see Figure oB-00042a). Two matching sets of sixteen coupons – one set in Tucson AZ and another in Livermore CA – were placed in water of four different chemical (alkalinity) qualities (40, 80, 120, and 160 ppm TA), exposing both the troweled and the molded sides of each plaster coupon to the four different waters. After a few months, small calcium nodules appeared on all four quartered slices/chunks of that one coupon (out of 16) at Tucson and the same matching coupon at Livermore in all four chemistries. The other 15 coupons did not form any nodules at all although they were submerged in the same four waters (see Figure oB-00042b). Interestingly, the calcium nodules only appeared on the troweled sides, not the molded sides (see Figure oB-00042c).
