Case History #oB-00005D

## onBalance Case History #oB-00005D

Re: onBalance Project oB-00005D

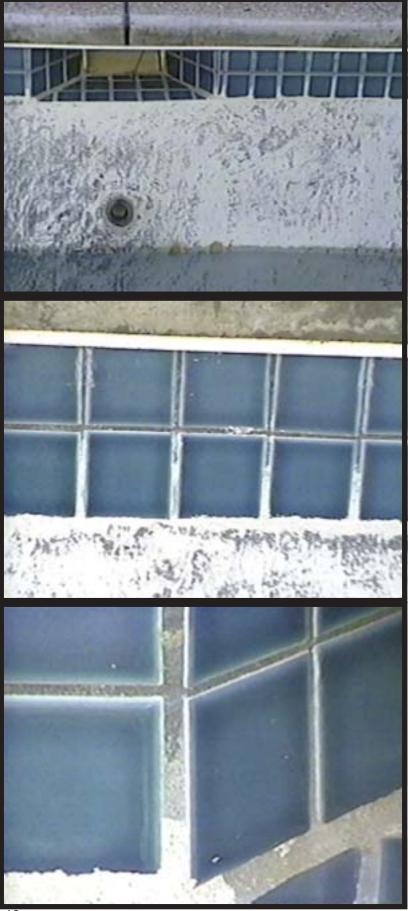
The "discolored grout" claimed by the plastering contractor as evidence that the plaster was not at fault is actually discolored plaster which was pulled up over the grout by the plastering crew, and not cleaned off (see attached photograph oB-00005Eb).

oB-00005Da – Sloppy cleanup – whitened plaster over grout below water level plus discolored wall

oB-00005Db – Sloppy cleanup – whitened plaster over grout below water level

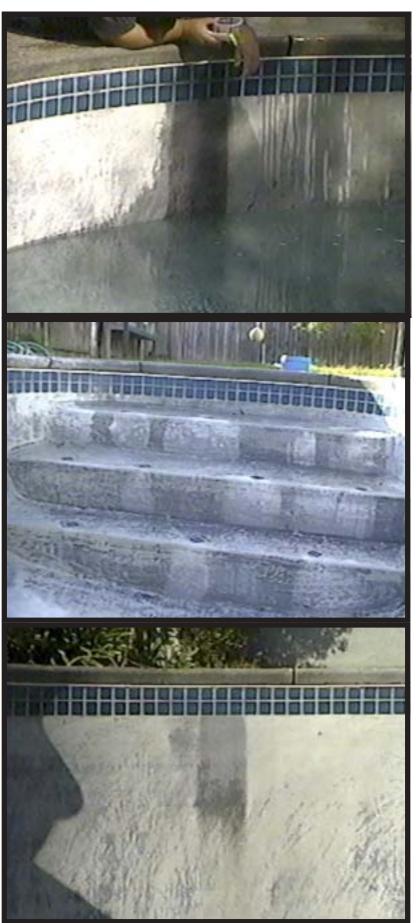
oB-00005Df – Walls showing "locally striped areas" (see Dr. Campbell's report). Note right-handed troweler pattern – pulling trowel over plaster from lower left to upper right

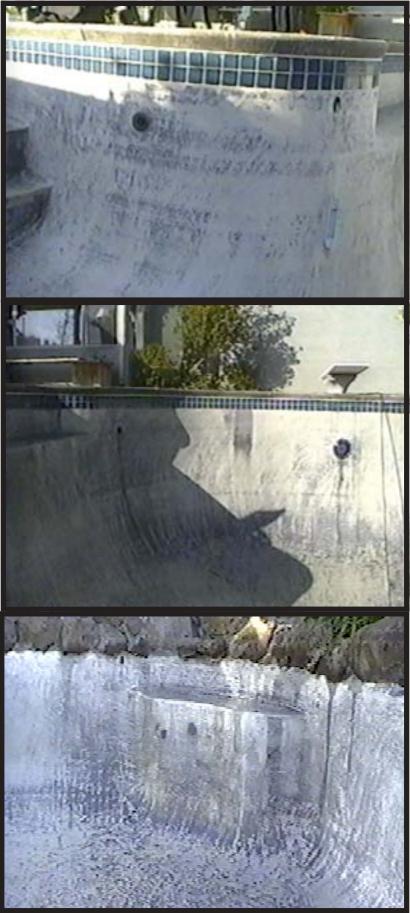
oB-00005Dg – Horizontal water lines and bottomto-top trowel pattern

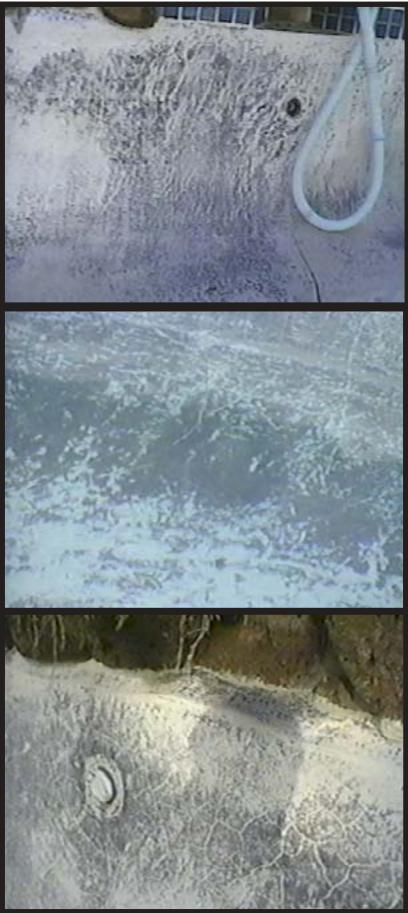
# oB-00005Dk – Discoloration

# oB-00005Dl – Discoloration by rocks

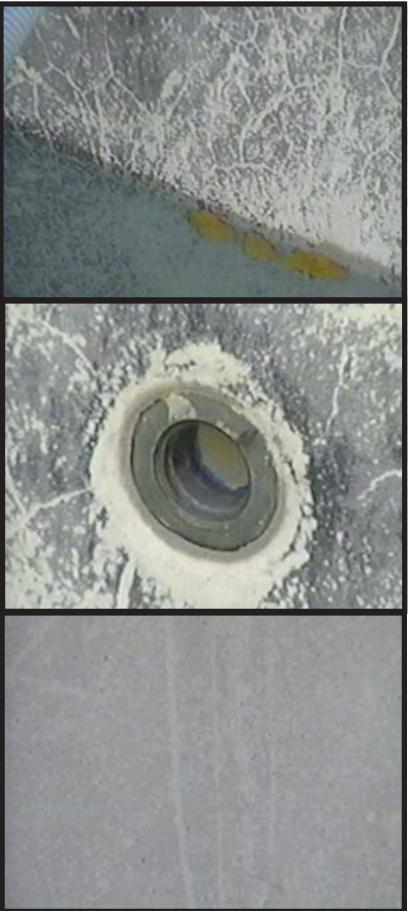
oB-00005Dm – Wall discoloration

oB-00005Dn – Discoloration around fitting

oB-00005Do – Drip lines on wall

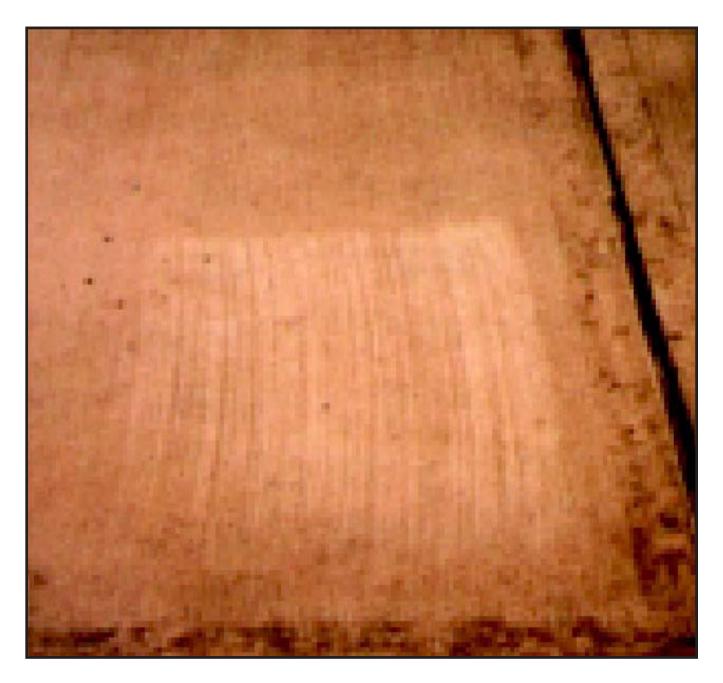
# Picture and Caption from Article Written by Davis Color Employee

"The pale broom mark, which is permanent, shows the first broom stroke after the broom was wetted." *Ensuring the Quality of Colored Concrete Finishes* – by Nick Paris [Davis Color] and Michael Chusid in The Construction Specifier, December 1998
