Plaster Soft Spots

onBalance – Que Hales, Doug Latta and Kim Skinner

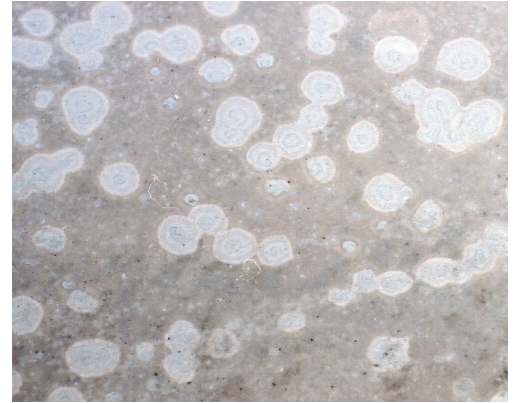
What does it look like? Generally round spots about the size of a pencil eraser to a dime, and usually much whiter than surrounding areas of the plaster (on both white and colored plaster). They may become tan or aqua over time by absorbing dissolved iron or copper. They may follow the edge of tile, highlight plaster cracks, or follow a troweled radius, or outline low spots in the plaster. They are usually surrounded by smooth, dense, intact plaster. Although aggregate (sand) is visible in the spotted area itself, the surrounding area is smooth cement paste. Even though the spot shows aggregate, the spot is relatively smooth.

How does it happen? Over-accelerated (and thus porous) plaster is late hard troweled, disturbing aggregate at surface. Water-troweling allows water to penetrate the paste-to-aggregate interface. Over time, water in the filled pool leaches soft paste from around the surface aggregate, and continues leaching in a pattern radiating from the point of origin.

Can it be prevented in the future? - Spotting can be prevented by reducing or eliminating calcium chloride accelerator use, proper timing of troweling operations, and eliminating wet-finishing techniques.

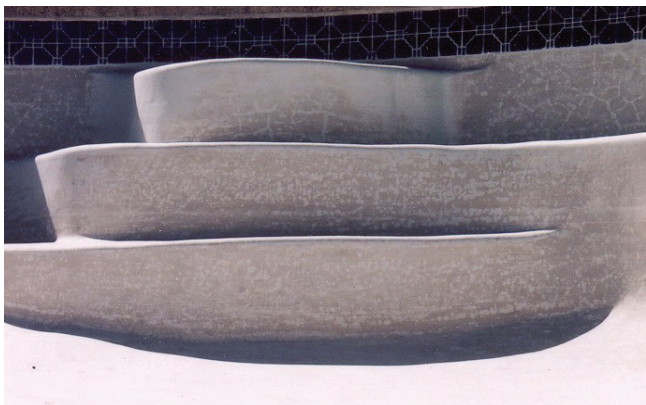
Plaster soft spots are surface blemishes that are caused by a combination of plastering errors. These include the over-use of calcium chloride set accelerant, and (as subsequent coping techniques) late over-troweling and adding water to the surface during late troweling.
