Case History #oB_0005M

Re: onBalance Project oB-00005M

You engaged onBalance to diagnose the cause(s) for discolorations on the surface of the swimming pool plaster located at [homeowner's address] in Tracy California, at the residence of [homeowner's name]. The onBalance partners visited the pool on a number of occasions, including two visits to obtain core samples of the pool for analysis. The following is a summary of the observations and results of the analysis.

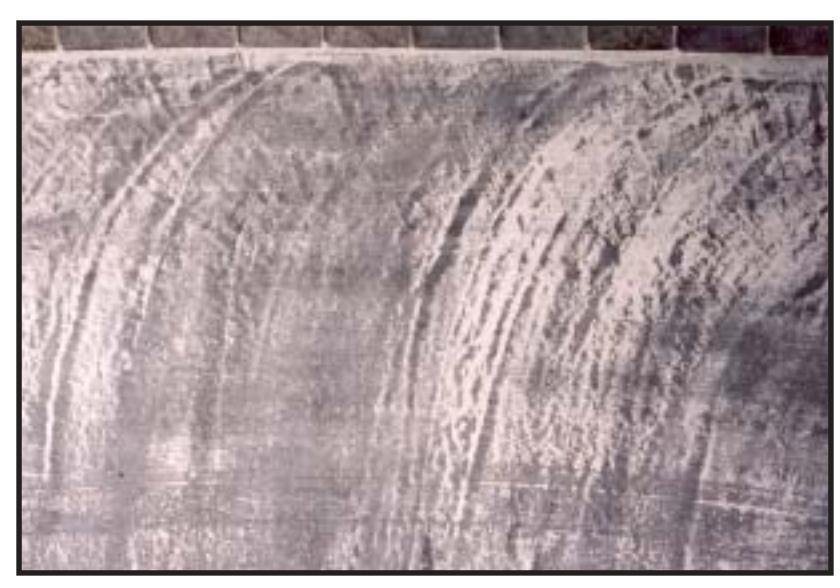
oB-00005M a – Pattern on wall

The grey plaster pool exhibits a spotted discoloration pattern, and the pattern coincides with fan patterns of discoloration, smeared material at surface, smeared plaster up onto the grout, driplines, etc. (see attached photo and microphotographs).

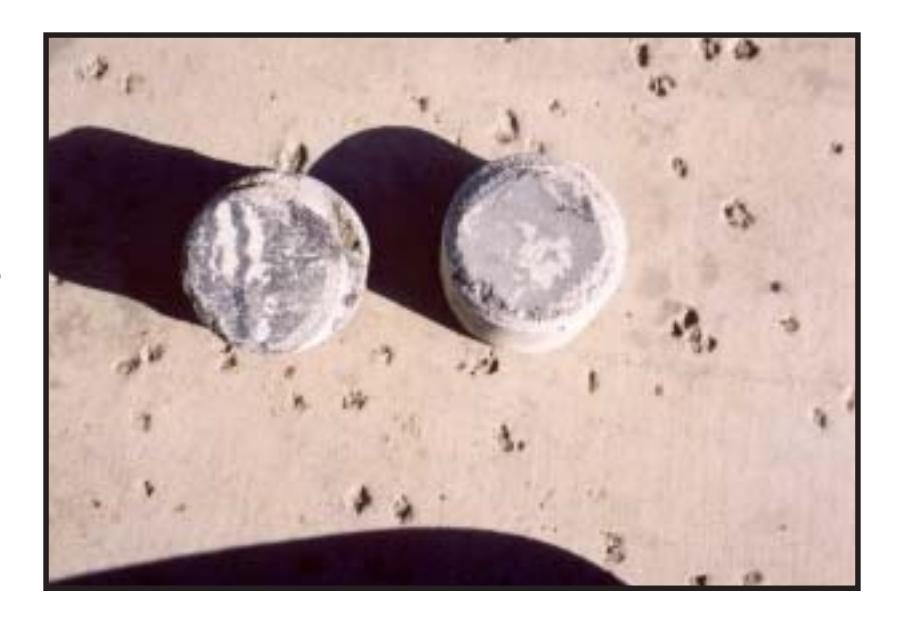
oB-00005M d - Cores

This plaster coating is thin, as seen in the photographs, which also may have played a role in the discoloration problems.
