Effects of Cyanuric Acid (Chlorine Stabilizer) on Swimming Pool Plaster Surfaces

Presley Kirkland Mitchell
Kirk Mitchell & Associates, LLC

A detailed investigation of plaster coupons exposed to simulated swimming pool water with a range of concentrations of cyanuric acid (CAS No. 108-80-5) was performed. Plaster coupons were prepared in accordance with customary industry guidelines based on input and guidance documents from the National Plasterer's Council. A six-month exposure and monitoring period accompanied by pre- and post-immersion surface roughness measurements as outlined in ANSI/ASME B46.1 and light optical photo-microscopic imaging was carried out. Routine water testing was done and accompanying chemical adjustments were made to maintain conditions within acceptable swimming pool water balance parameters. No measurable surface deterioration via surface roughness and optical photo-microscopic imaging was observed up to 250 mg/L cyanuric acid, the highest cyanuric acid concentration tested.

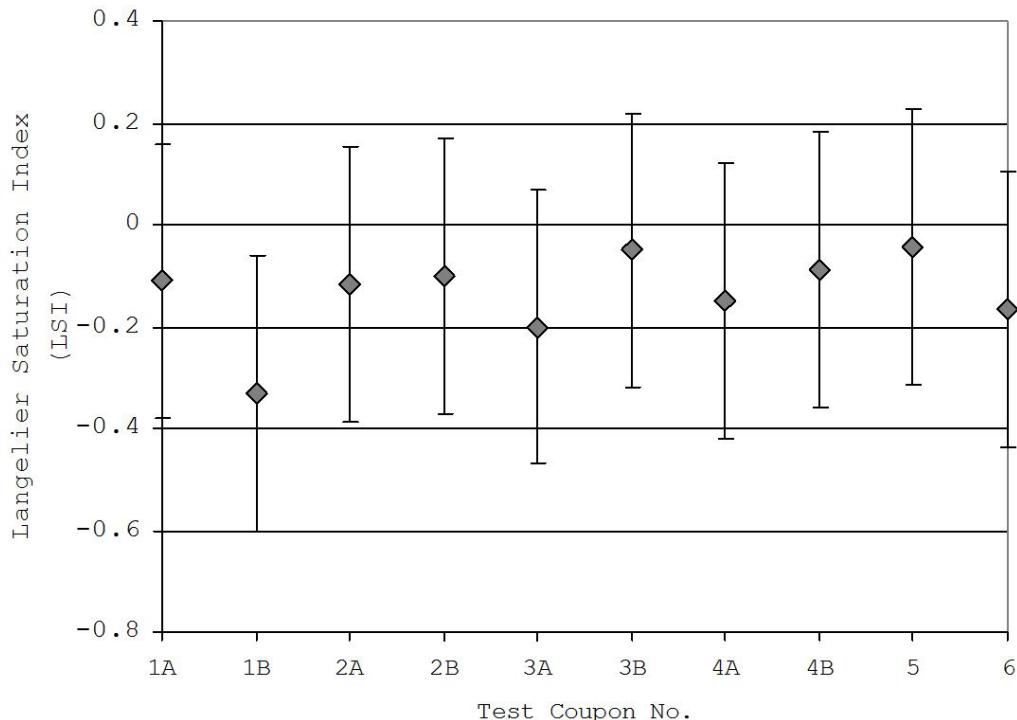
Figure 1 — Langelier Saturation Index (LSI) values for test tank/coupons

LSI values less than -0.3 denote significant under-saturation of CaCO_3 , indicating that the plaster will tend to dissolve. LSI values greater than 0.5 indicate significant over-saturation of CaCO_3 , indicating that CaCO_3 will tend to precipitate from the water, leading to scaling. Figure 1 summarizes the average LSI and associated standard deviation of the test solutions during exposure of the test coupons. As these results show, all test tanks with the exception of 1B yielded average LSI values within the industry

acceptable range of -0.3 to +0.5. Test tank 1B had a calculated average LSI value of -0.33, which was only slightly outside of the recommended range. Therefore, all test coupons in this study were exposed to solutions that were non-aggressive according to LSI, despite the high levels of cyanuric acid.

Figure 1 graphically highlights the average calculated Langelier Saturation Index (LSI) and accompanying standard deviation. A total of 32 data points were used to calculate the average LSI and standard deviation for each test tank shown.

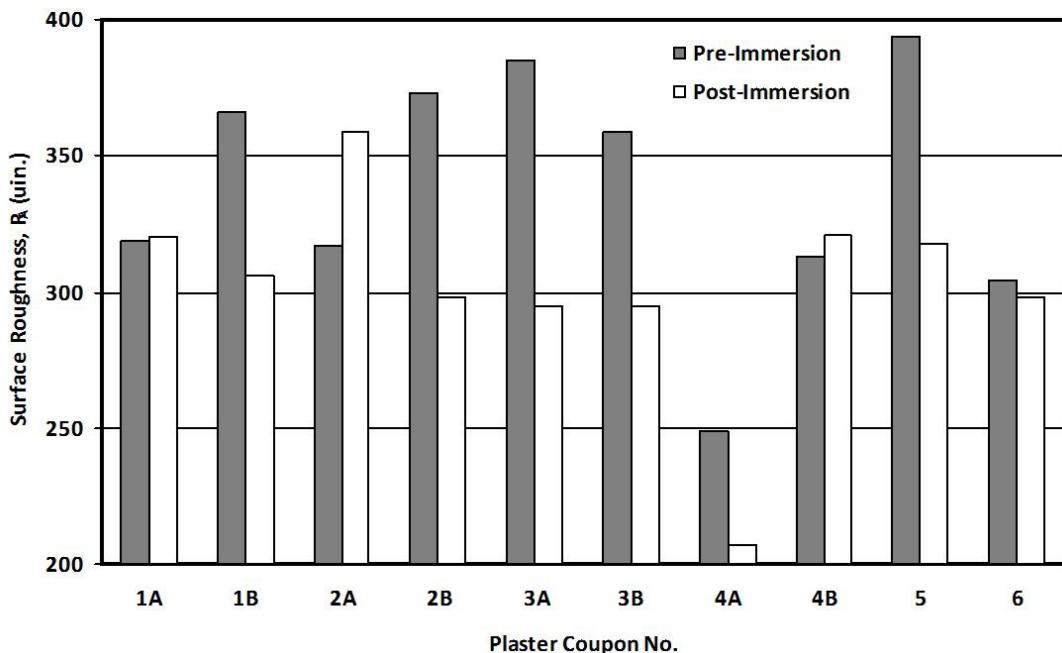
Figure 2 — Pre- and Post-Immersion Surface Roughness

The surface roughness of each plaster coupon was measured pre- and post-immersion, as outlined in the Surface Characterization section. Figure 2 depicts the surface roughness (R_A) results. Only one coupon (#2A) exhibited a higher R_A value after immersion (Figure 2), indicating the plaster surface was rougher after the 6-month immersion period. The surface character of three

plaster coupons (#1A, 4B and 6) were essentially unchanged following the six-month exposure period, whereas the remaining plaster coupons (#1B, 2B, 3A, 3B, 4A and 5) were smoother at post-immersion (Figure 2).

As shown in Figure 2, only one coupon (#2A) exhibited a higher R_A value after the six month exposure period, pointing to a slightly rougher post-immersion surface. All other test coupons exhibited no appreciable difference between the pre- and post-immersion surfaces or a smoother post-immersion surface, even for those coupons exposed to the highest cyanuric acid levels (#4A, 4B, 5 and 6) as presented in Table 2. These observations diverge from prior work (Reference 3) performed to assess the impact of cyanuric acid on plaster surfaces but support the findings reported by onBalance (Reference 4).

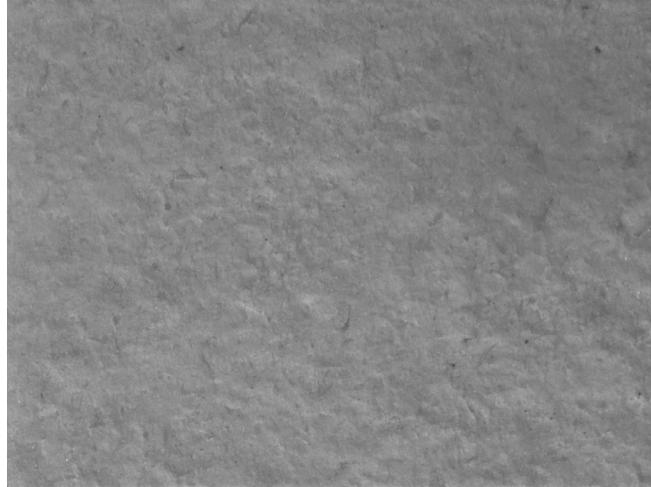
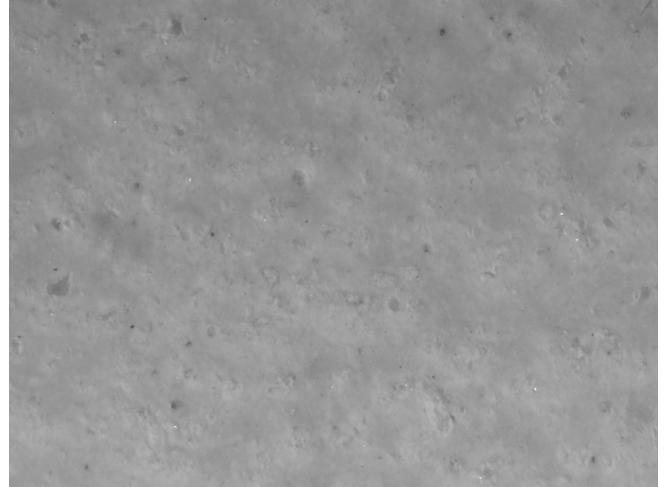
Image 1 — Light optical photo-microscopic imaging Test Coupon 4A

mersion Test Coupon 4A at 15X magnification (Image 1a) and Post-Immersion Test Coupon 4A at 15X magnification (Image 1b) exhibit side-by-side optical photo-microscopic images of Test Plaster Coupon 4A at 15X magnification in the 250 mg/L CYA test solution. The post-immersion image portrays a smoother surface character which is consistent with the measured surface roughness (R_a) results shown in Figure 2.

Left: (a) Pre-Immersion Test Coupon 4A at 15X magnification

Right: (b) Post-Immersion Test Coupon 4A at 15X magnification

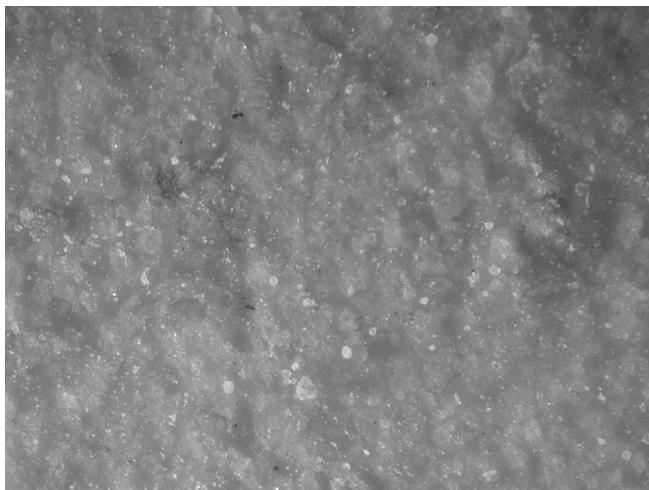
Image 2 — Light optical photo-microscopic imaging Test Coupon 2B

Left: (a) Pre-Immersion Test Coupon 2B at 50X magnification

Right: (b) Post-Immersion Test Coupon 2B at 50X magnification

Test Coupon 2B at 50X magnification (Image 2b) exhibit side-by-side optical photo-microscopic images of Test Plaster Coupon 2B at 50X magnification with steadily increasing concentrations of cyanuric acid derived from weekly incremental doses of approximately 12 mg/L. The final cyanuric acid concentration of Test Tank 2B was 267 mg/L (Table 2). No significant difference was observed between the pre- and post-immersion photos.

In addition, the post-immersion coupons do not show any of the cracking or surface modification reported in the Arch study. Very similar results were found for all the other test coupons in this study – the surface texture showed no significant differences between the pre- and post-immersion coupons.
