Case History
#oB-00015

Re: onBalance Project oB-00015 (Kennett)

You engaged onBalance to diagnose the cause(s) for discolorations on the surface of the swimming pool plaster located at 14637 N. 55th Street in Phoenix Arizona, at the residence of John and Kitty Kennett.

**EVALUATION OF SURFACE DISCOLORATION
SWIMMING POOL PLASTER**

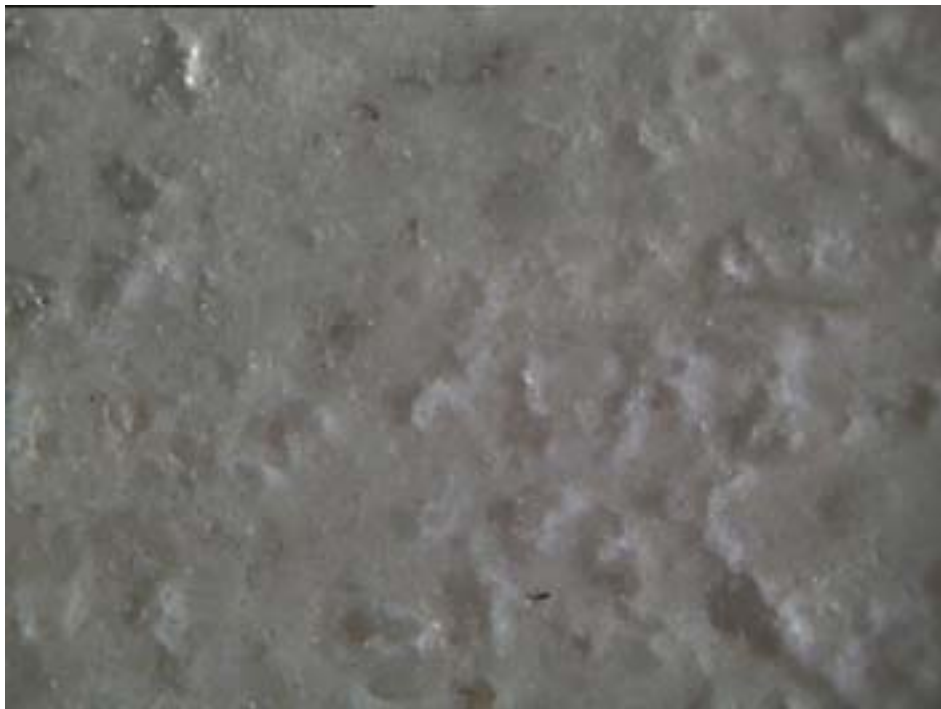
The microphotographs of the Kennett plaster were compared by onBalance with photographs of other plaster standards (at the same magnification) which had been subjected to known degrees of aggressive chemical attack (Figures 17 – 21).

Figure 16 – Aggregate Exposure of Kennett Pool Surface

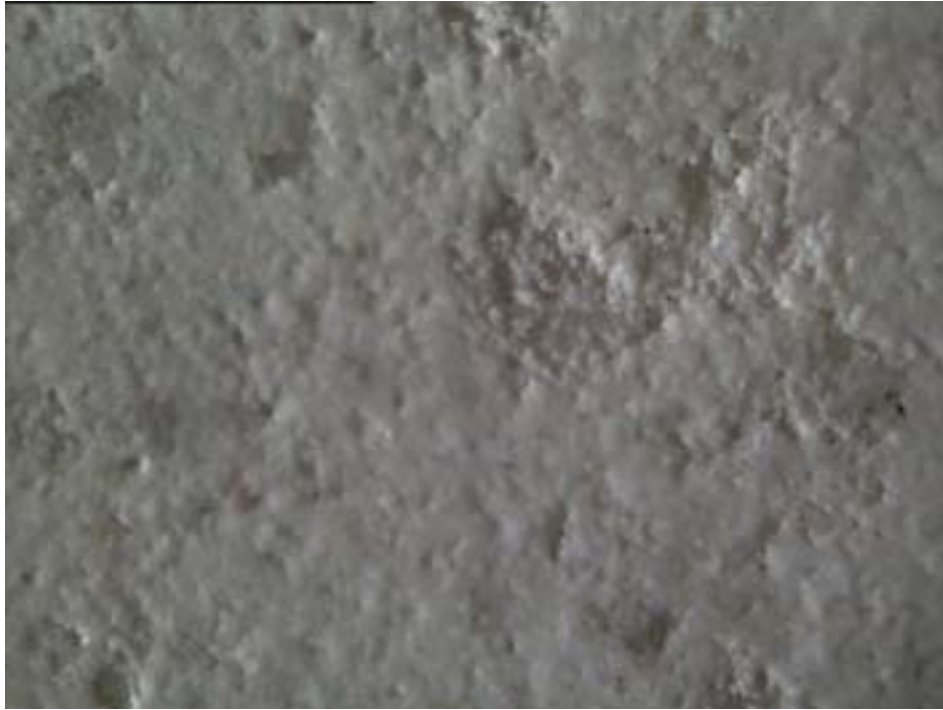
Figure 17 – Aggregate Exposure of Unetched Plaster (Unexposed to Water)

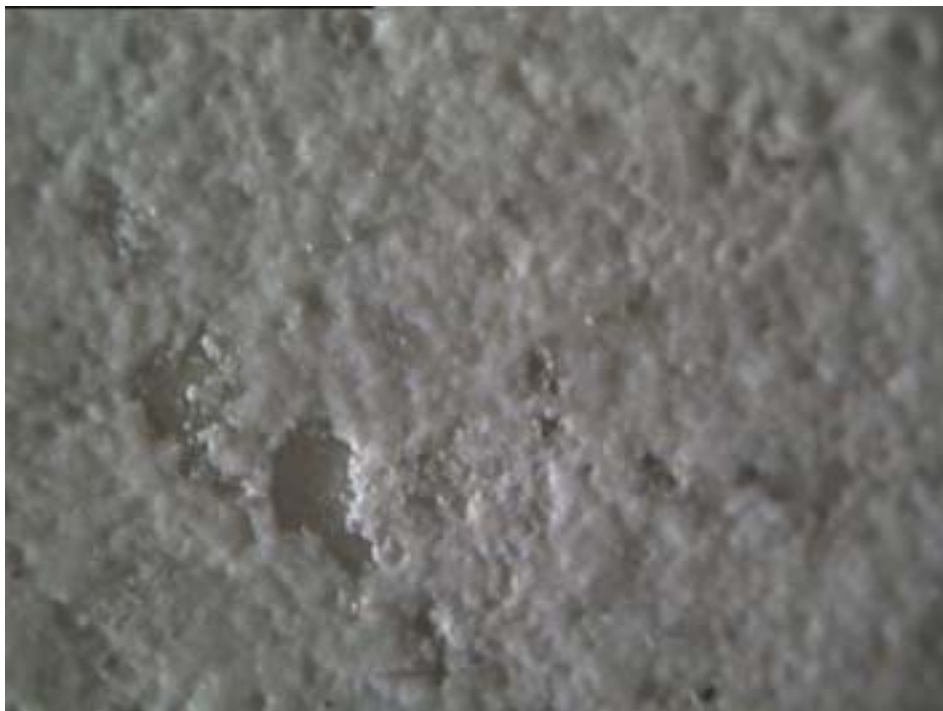
Figure 18 – Aggregate Exposure of Plaster Cured in Balanced (Non-aggressive Water)

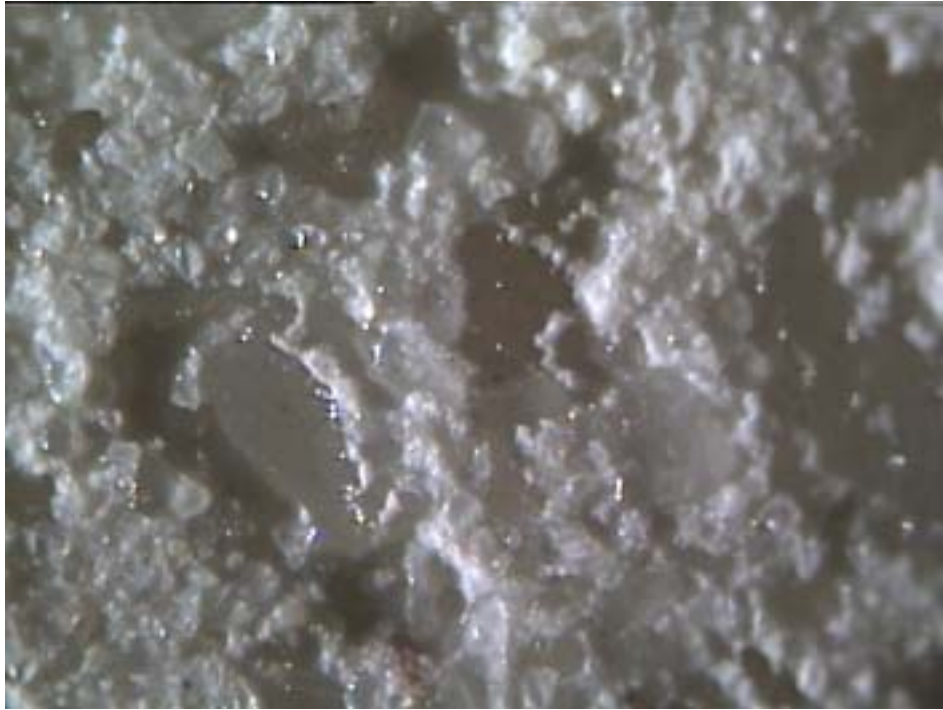
Figure 19 – Aggregate Exposure of Lightly Etched Plaster

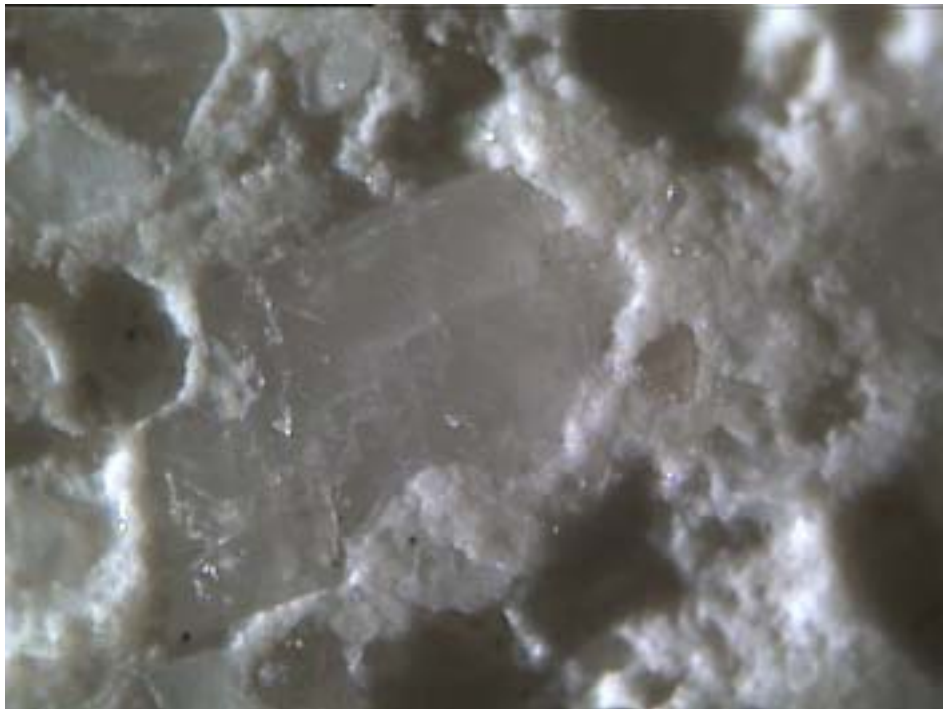
Figure 20 – Aggregate Exposure of Moderately Etched Plaster

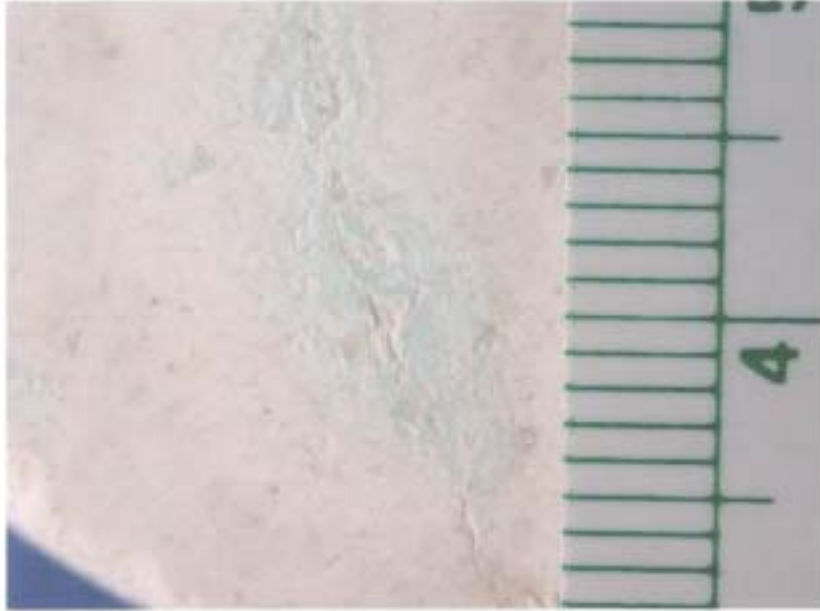
Figure 2.

Evidence of re-tempering on the surface is not observed in figure 1 and 2; the paste surface is relatively smooth. Figure 2 shows the sample in oblique lighting; relief due to re-tempering is not evident. Previous studies of samples obtained by OnBalance (e.g. report date 7/13/2001) have documented that re-tempering relief (an over-trowelled surface) directly corresponded to "spot etching".

Relief is observed, in figure 2, decorating the length of the crack due to efflorescence, indicative of a calcium rich material. From our discussions, this phenomenon seems to be generally termed nodular growth in the swimming pool industry. A green discoloration is observed also decorating the crack. Figures 3, 4 and 5 show higher magnifications of the efflorescence. The stereo optical images do not show evidence of "disrupted" paste indicative of an aggressive solution (surface attack due to acidic water conditions). This surface phenomenon is exemplified in a previous study (report date 2/6/02) where eight plaster coupons were subjected to various curing regimes and acidic water conditions (by OnBalance).

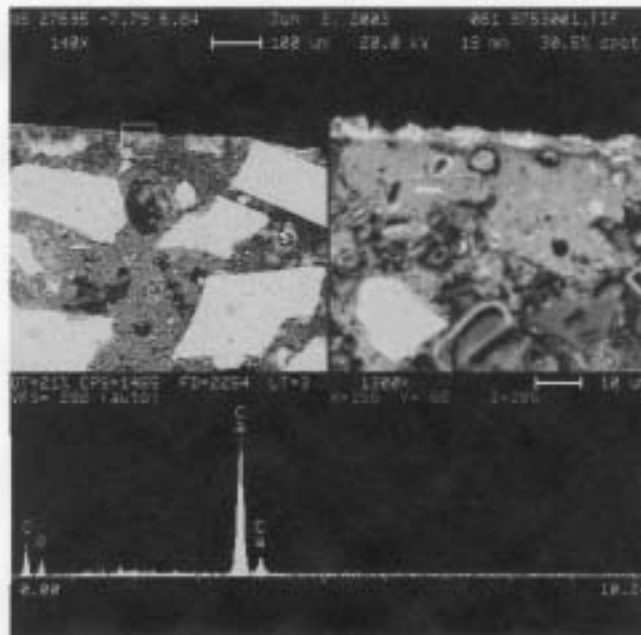
Figure 7.

Figures 7, 14 and 15 show cracking throughout the paste. Figure 7 shows a shrinkage crack pattern in a region away from the affected region and is typical of the general paste structure. The implication is that the crack pattern predates the affected region. Figures 14 and 15 are high magnification images taken of the cross-section along the crack shown in the stereo optical images. The images show that a calcium rich phase, indicative of calcium hydroxide decorates the crack. The morphology of this calcium hydroxide matches the structure of the crack, confirming that the calcium hydroxide formed after the crack had formed. The images also show a porous highly siliceous region decorating the crack.

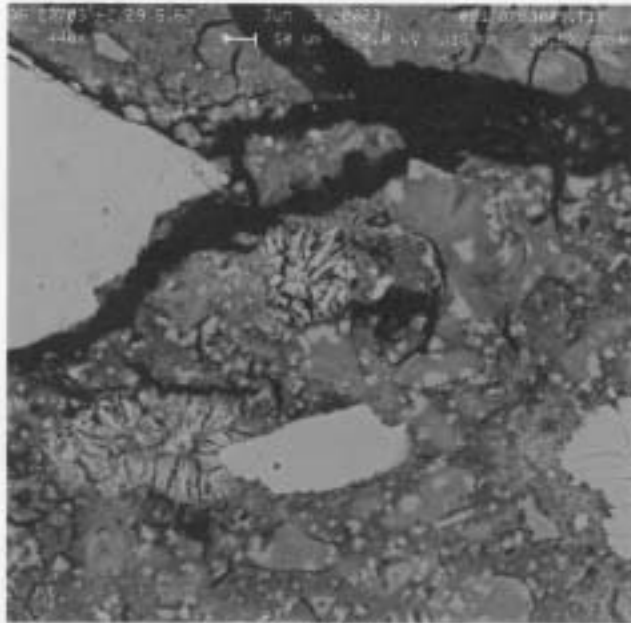
Figure 10.

Figure 10,12 and 13 show depositions of ettringite, a calcium aluminosulfate hydrate compound. Ettringite depositions are observed along cracks and in highly porous regions, indicating the depositions are formed during the paste reconstruction occurring during the movement of calcium through the paste. The ettringite deposits have thus formed after the formation of the highly porous regions.

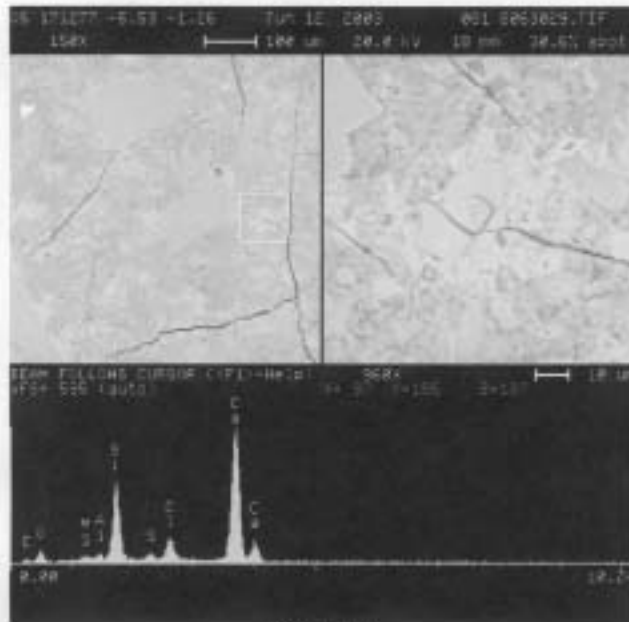
Figure 16.

Figures 16 and 17 show a high content of chloride is present in the paste. The chloride concentration is high enough that not only are Freidel salts present, but also increased chloride content is observed in calcium silicate hydrates.
