# An Update on the Cause of Swimming Pool Plaster Efflorescence (Calcium Nodules)

Que Hales, Doug Latta and Kim Skinner - *onBalance*

*Swimming pool plaster samples exhibiting calcium nodule growths have been analyzed by cement petrographers, and the findings are consistent with the model proposed by onBalance in a 1998 JSPSI article.*

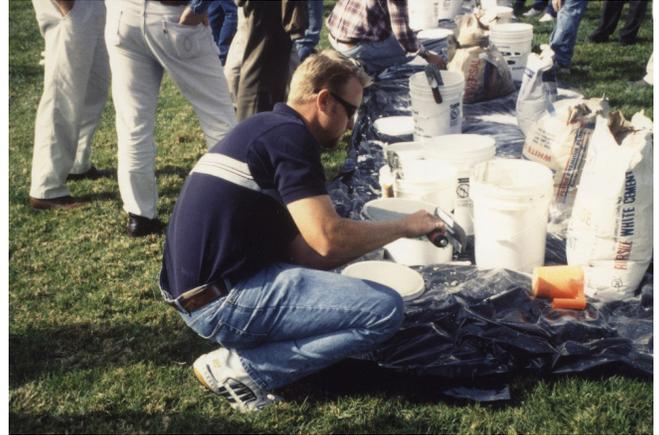
Figure oB-00042a – Forming the Coupons

*The nodule growth on the top surface of the coupons is calcium carbonate*  
Volume 6 Number 2 – Spring 2023

*Shrinkage cracking of the coupons and leaching of calcium from the paste was promoted by calcium chloride content, apparent from the distinctive map crack pattern developed in high (10 Wt. %) calcium chloride content standard plaster.*
