Overview

The study, sometimes referred to as the phase 1 study, appears to use rather robust full-factorial experimental design, and draws some strong conclusions on water chemistry being the principal cause of plaster etching, while addition of calcium chloride appears to make plaster more resistant to etching. However, upon closer examination a number of deficiencies appear in the execution of the study: not all relevant variables were taken into account—leading to an unbalanced experimental design with confounded variables; the control variables were routinely out of control; once deficiencies were detected, the authors improvised on the fly and continued rather than restarting the experiment with the problems corrected so as to ensure more reliable data; and there was a clear lack of familiarity with the chemistry of water treatment, or chemistry in general. In addition, the presence of multiple uncorrected errors in the report makes it evident that the report was never peer reviewed. Given the number of deficiencies in the execution of the experiments and evaluation of the results, it is difficult to have any confidence in the data generated or the conclusions drawn. The foll

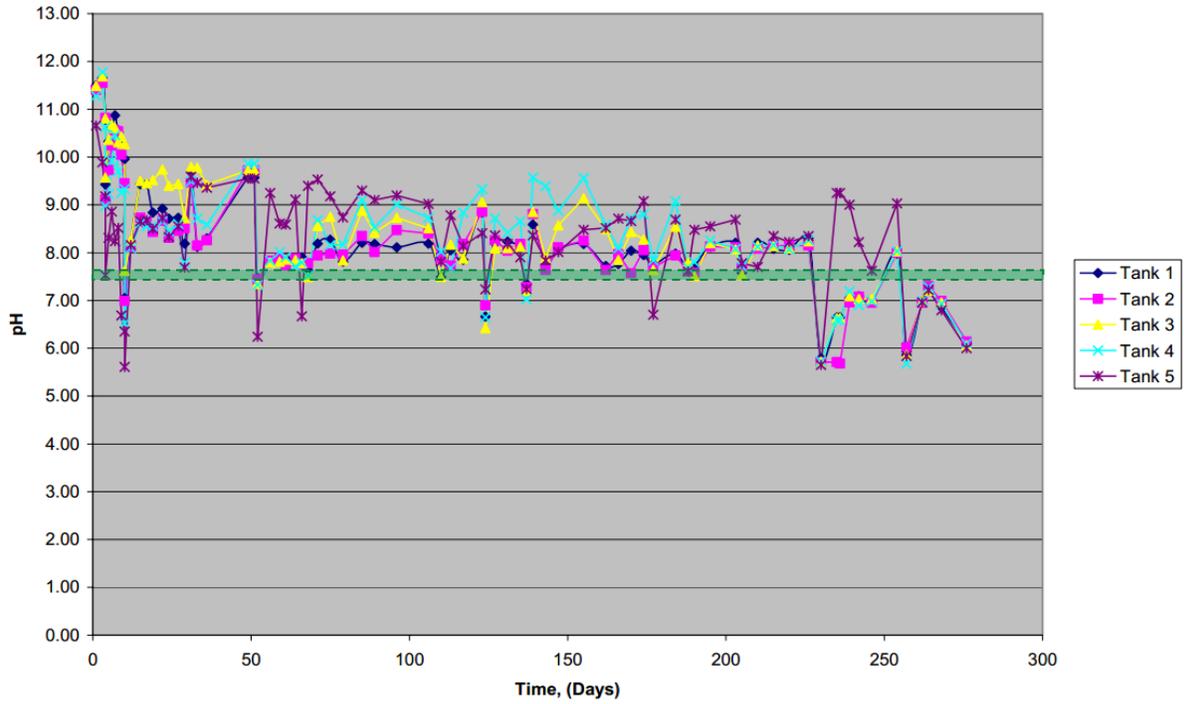
Figure 1. Plot of tank pH from Figure 5.3 in Cal Poly report. The transparent green band denotes the target pH range of 7.4 to 7.6.

In Table 2-2 (p. 18) and on page 42 it is indicated that the objective was to maintain the pH at 7.2 to 7.4; however, as shown in Figure 1, below, the pH was typically above this range, and often below it, but rarely inside the target range in any of the tanks. Commonly the pH was more than a full unit outside the “control” range. What’s worse is that the pH in tanks 3 and 4, the “aggressive” water tanks, was typically higher than in tanks 1 and 2, which were designated as balanced. Such lack of pH control is especially problematic since pH is the most sensitive determinant of calcium carbonate saturation. (For either carbonate alkalinity or calcium hardness to have an impact equivalent to the pH being a unit outside the target range, the alkalinity or hardness would have to be outside their respective control ranges by a factor of 10!)

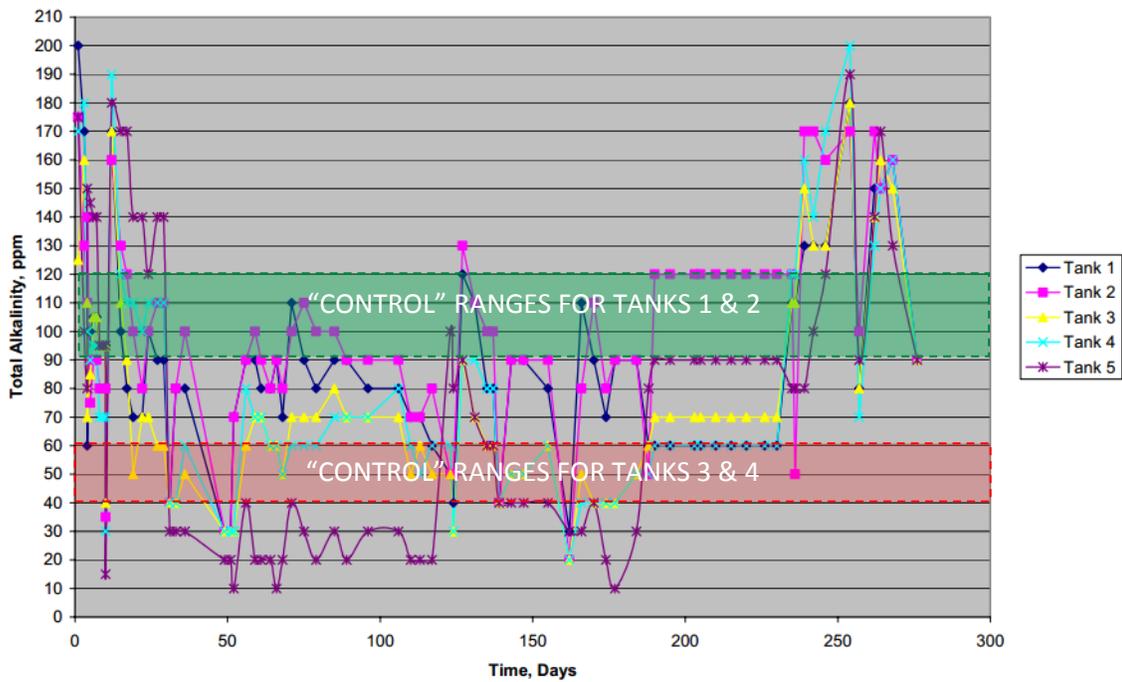
Figure 2. Alkalinity plot for tanks from Figure 5.6 in Cal Poly study. The intended control ranges are indicated by the red and green transparent bands.

As shown in Figure 2 on the next page, total alkalinity was also out of range more often than it was in range. The alkalinity for the “aggressive” tanks, 3 & 4, was often above the control range, while for the “balanced water” tanks (1 & 2), alkalinity swung above and below the target range.

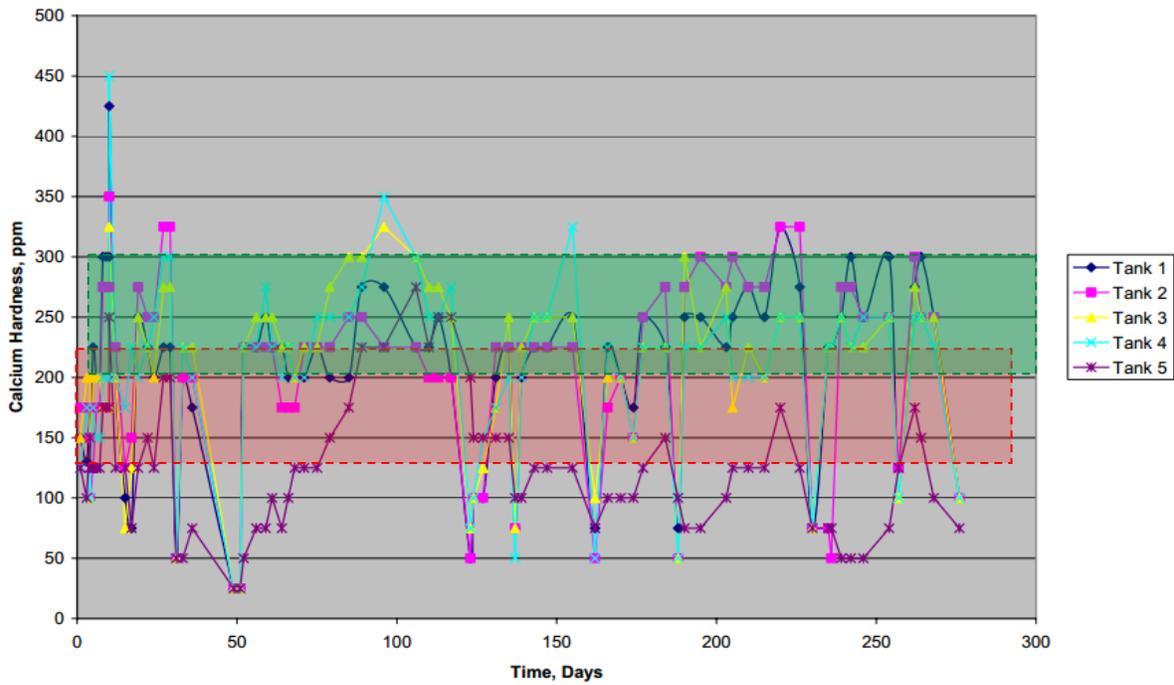
Figure 3. Calcium hardness plot for tanks in Cal Poly study. From Figure 5.7 in Cal Poly report.

Similarly Figure 3 shows that calcium hardness was also often outside the designated control ranges for the respective tanks.

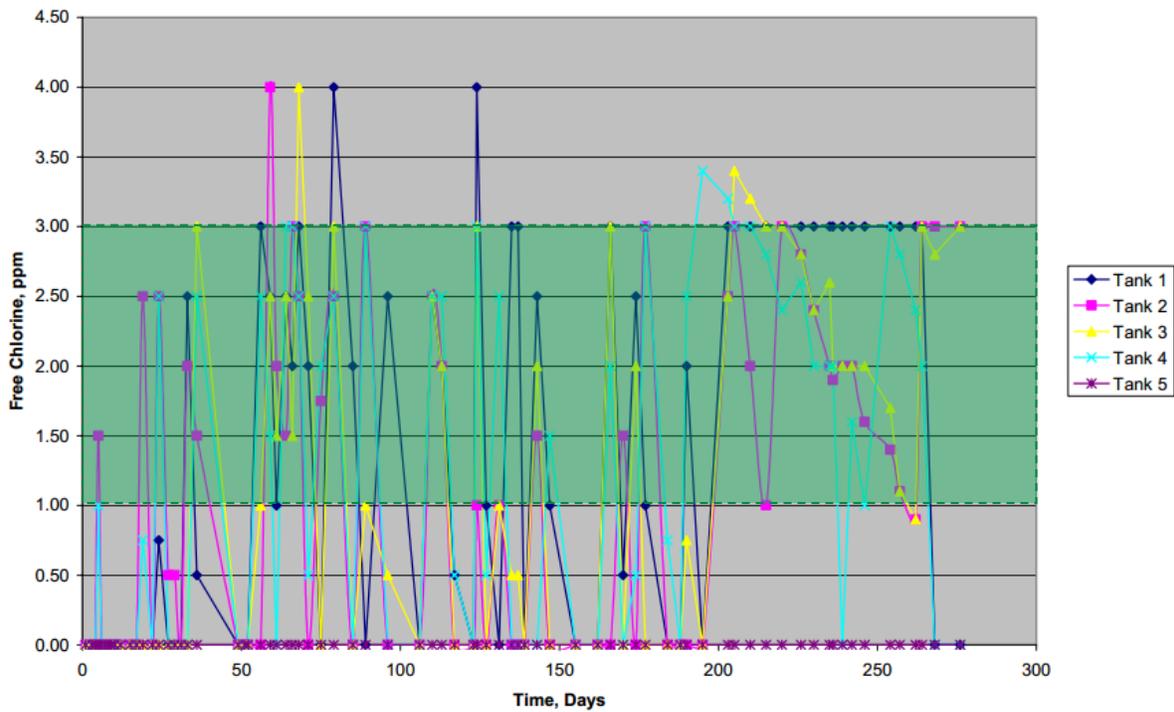
Figure 4. Free chlorine in tanks, from Figure 5.4 in Cal Poly report. The green band denotes the target range for tanks 1-4.

As a final out of control water chemistry influence, Figure 4 shows that while the target free chlorine range was 1 to 3 mg/L, the measured free chlorine level was often zero, introducing the possibility of biofilm gaining a foothold on the plaster, an opportunity for unplanned corrosive influences.

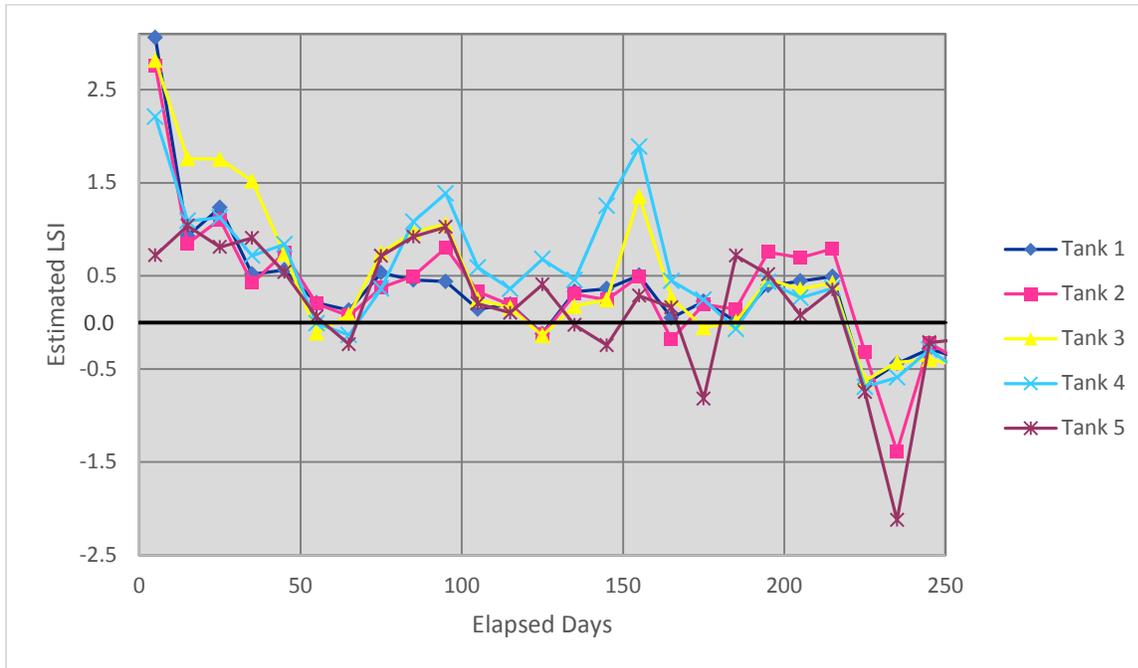
Figure 5. Estimated LSI for the 5 tanks used. Note that tanks 1 and 3 were treated with trichlor. This could have resulted in cyanuric acid accumulation and a resultant downshift in the LSI of 0.1 to 0.2, relative to the plots shown.

It is unlikely that any etching or spot alteration could be reliably correlated with control variables, given how out of control those variables actually were. Nevertheless, the authors concluded that “the water chemistry is the single, most important parameter influencing the spot-etching deterioration of the plastering surface.” This finding is at odds with the little data actually provided in the report. To illustrate this, consider the following graph of the LSI (Langelier Saturation Index) versus time for the five tanks (Figure 5).

The LSI was estimated using the pH, alkalinity, calcium hardness (Figures 1-3 in this critique) and the temperature in Figure 5.1 of the phase 1 report. Since no data were provided for TDS (total dissolved solids) or ionic strength, a value of 600 ppm TDS was assumed. In addition, each point in the Figure 5, below, is based on a rough average of 10-days-worth of data for each input parameter (pH, alkalinity, calcium hardness, and temperature). Given the crowding of points early in the study, a precise daily

It should also be noted that no data were provided on the concentration of cyanuric acid in the tanks. Therefore, the LSI plotted does not take into account the contribution of cyanuric acid to total alkalinity, and the LSI plotted is based on the total alkalinity. Since tanks 1 and 3 were treated with trichlor (*trichloro-s-triazinetriene*), it is possible that CYA (cyanuric acid) may have sometimes accumulated to as high as a 50 ppm concentration in these tanks, depending on the frequency of water replacement relative to the rate of trichlor addition. Taking a 50 ppm CYA concentration into account would shift the affected LSI downward by ~0.1–0.2. Nevertheless, Figure 5 gives a reasonable picture of the relative LSI values for the five tanks.

Figure 5 and Tables 1 and 2 provide some telling information:
