# A Critique of the Dow Whitney Report

Que Hales, Doug Latta, and Kim Skinner  
*onBalance*

**Journal of the Swimming Pool and Spa Industry**

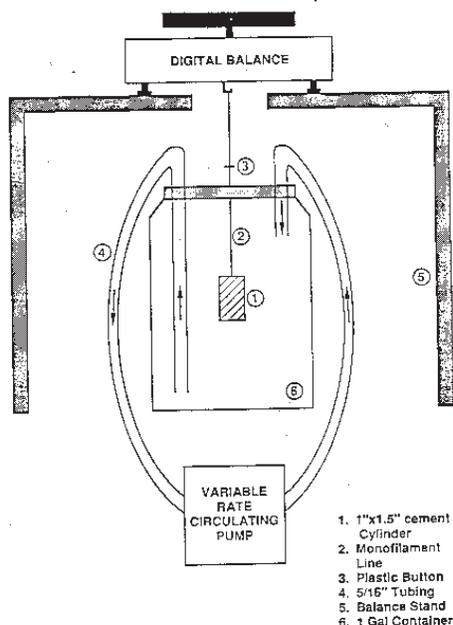
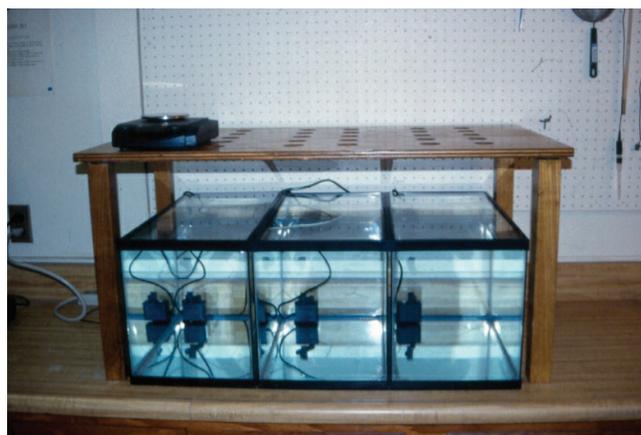
After drying, each of the ten 0.4 w/c samples were suspended in a 10 gallon aquarium filled with 10 gallons of distilled water, and were left to equilibrate for four days (see Figures 1 and 2 for illustrations of the set-ups). The same process was followed with the 0.45 w/c and 0.5 w/c coupons. (The same procedure was also followed with the aggre-

**Figures 1 and 2 – Diagram from Dow Whitney Report of Test Set-up and Photograph of Tucson Test Set-up**

In order to see what coupons actually look like when subjected to the “Dow Whitney” conditions, and to document the actual type of etching which results from extended low pH, the Whitney experiment was repeated at the Pool Chlor lab in Tucson Arizona.

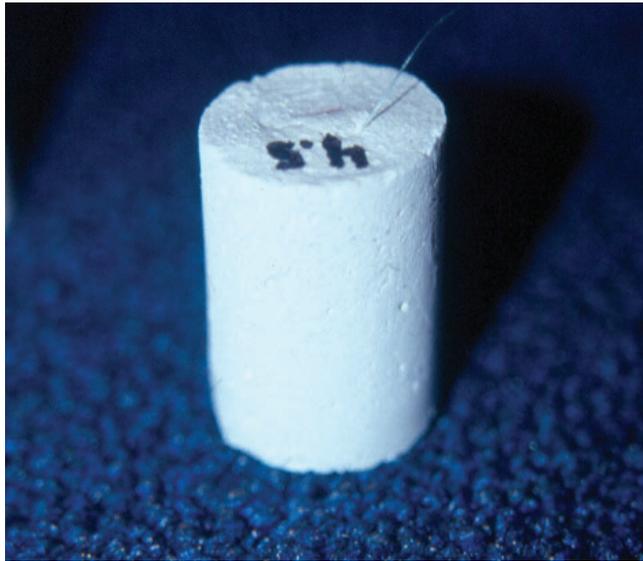
**Figure 3 – One of the 0.45 Cement:Water Ratio Coupons from Tucson Test Set-up (Before Six-month submersion)**

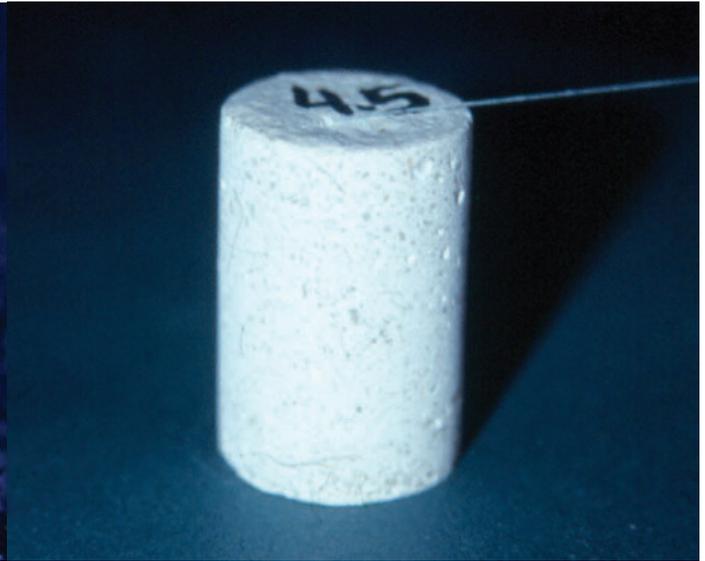
calcium hydroxide is concentrated in round spots of the plaster surface, and that any leaching of calcium hydroxide from the plaster comes only from these spots. Our re-creation of the experiment contradicts Dr. Whitney's verbal assertion that the coupons etch "preferentially in round spots" – a point that has been used by some in the industry to attempt to explain the spot etching phenomenon.

**Figure 4 – One of the 0.45 Cement:Water Ratio Coupons from Tucson Test Set-up (After Six-month submersion)**
