# Flaking, Spalling and Delaminations

by *onBalance* – Kim Skinner, Que Hales, and Doug Latta

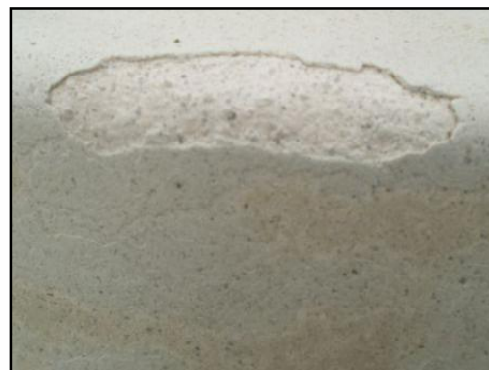
If this happens, the top of the finished plaster will look fine, even for awhile after the pool is filled. However, after time this weakness is manifest by a 16<sup>th</sup> to an 8<sup>th</sup> inch layer of the surface flaking off, generally in small areas or spots. Often, these weak areas do not flake off until the pool is drained of its water and the plaster dries out.

You can see the round indented area with the loss of plaster. This could be described as a moon like crater look, or a shallow and sunken pit look. Note that the newly exposed surface (where the flaking occurred) is extremely rough and coarse, while the older existing surface surrounding the missing plaster area is much smoother.

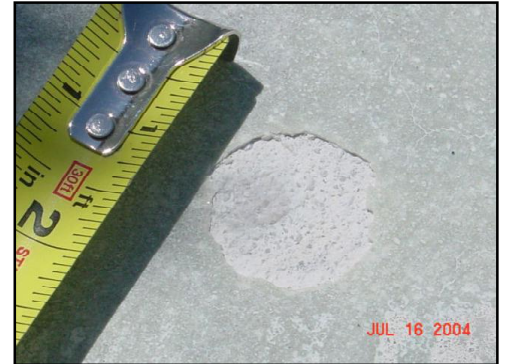
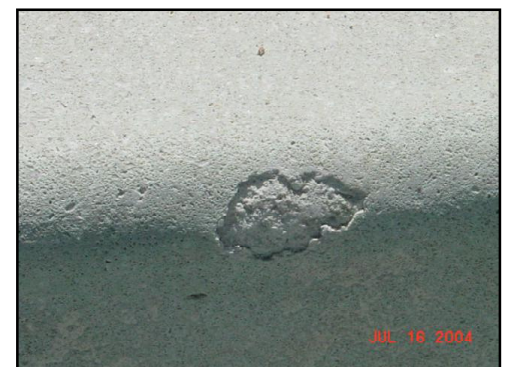
Since the vast majority of pool plaster does not spall, blister, or flake off, we can see that most plasterers properly apply, cure, trowel, and finish the pools they plaster. Spalling is relatively rare, and when it does occur it is most commonly found on a step radius, on shallow end floors, and around the main drain of these being places where finishing can be an additional challenge for a number of reasons. The step radiuses are occasionally over-worked to insure smoothness and straightness, and the floors sometimes

get too much troweling due to being walked on by the pool finishers while troweling. Walls are rarely over-troweled.

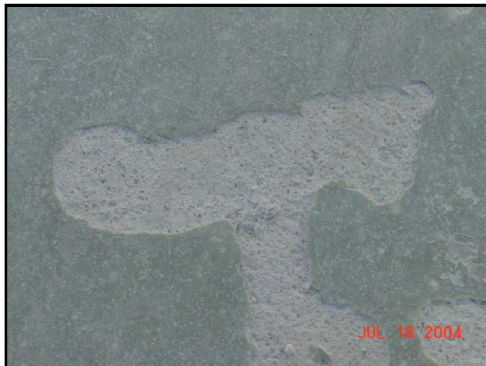
- o If aggressive water caused spalling in swimming pools, we would also see aggressive etching of the exposed aggregate in the spalled pit. We don't.
- o And if aggressive water could cause spalling in pools, we would also see spalls on the top step of pools where a trichlor feeder has sat. Instead, in that situation we see acid-etched rings, not spalls.
