# Grey Discoloration of White Swimming Pool Plaster

by onBalance

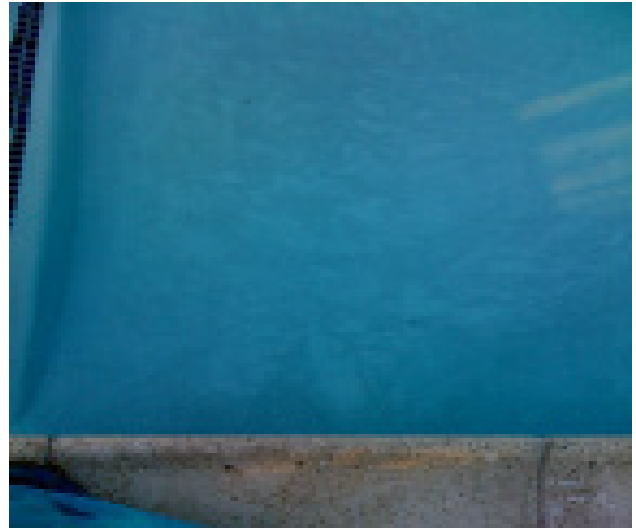
The picture at right shows grey discoloration of a fairly new white swimming pool plaster surface. This discoloration develops over time, and usually appears sometime in the first year. In some cases, once it becomes noticeable, it can progress throughout the swimming pool. No change in water chemistry stops the progression of the discoloration. Acid treatments are largely ineffective at addressing this discoloration, although occasionally an acid wash will lighten it. Some plasterers have drained swimming pools with this problem and left them empty for several days, allowing the plaster to “dry out”. Anecdotal evidence shows that this is a hit or miss proposition, and in some cases, the discoloration has reappeared sometime after the swimming pool was refilled. The application of heat, using a process often called “torching,” has been effective in many cases of this greying discoloration. The surface is superheated using hand torches, the premise being that water trapped subsurface in the plaster is removed by the heat. However torching is a painstaking and inexact process, and small areas of the surface can pop off during the application. Most often, there is no effective remediation of the problem. This greying often accompanies other surface discolorations including so-called “spot etching”.
