## **onBalance Case History #oB-00005E**

The (homeowner name) pool on (homeowner address) in Tracy California was built by Aqua Pool and Spa, and plastered by Burkett Pool Plastering. According to the records of Aqua Pools and Spas, the pool was built and plastered in September of 1998, and turned over to a service company, Aqua Chlor, who started the service on 9/2/98. On that first day of service, the service company already documented that the pool surface had “white spots and streaks throughout pool and spa – mottled.”

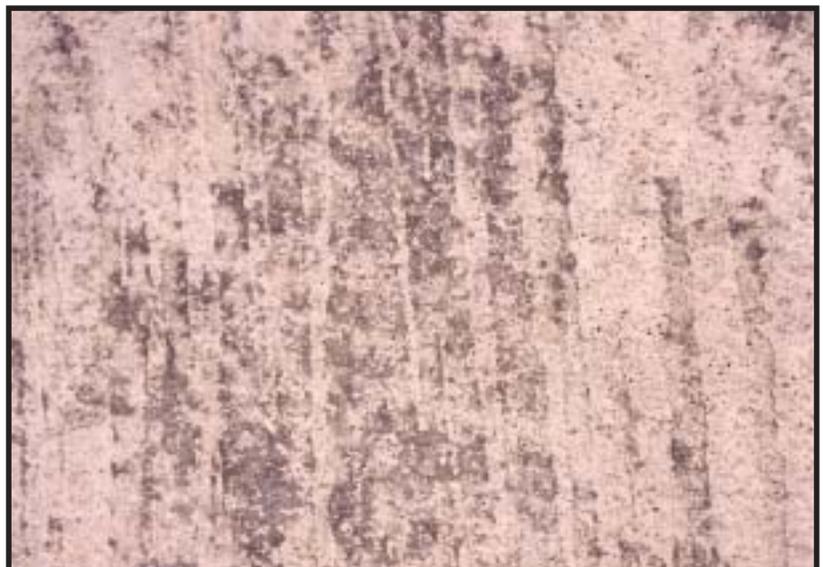
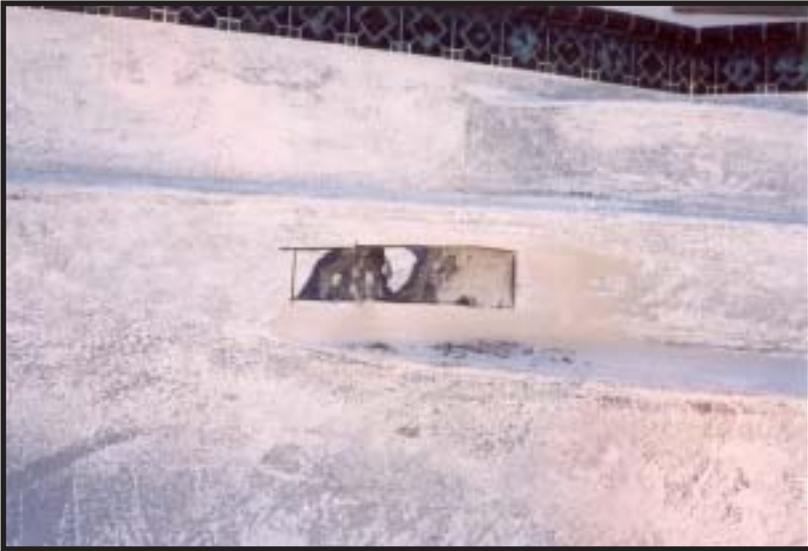
**oB-00005Ef – Trowel-pattern streaking on surface highlighted by discoloration**

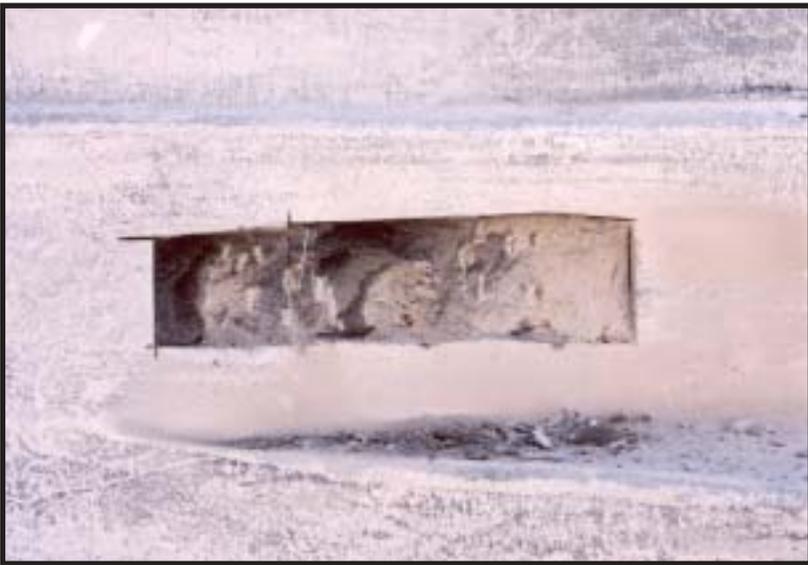
**oB-00005Eg – Plaster samples *in situ***

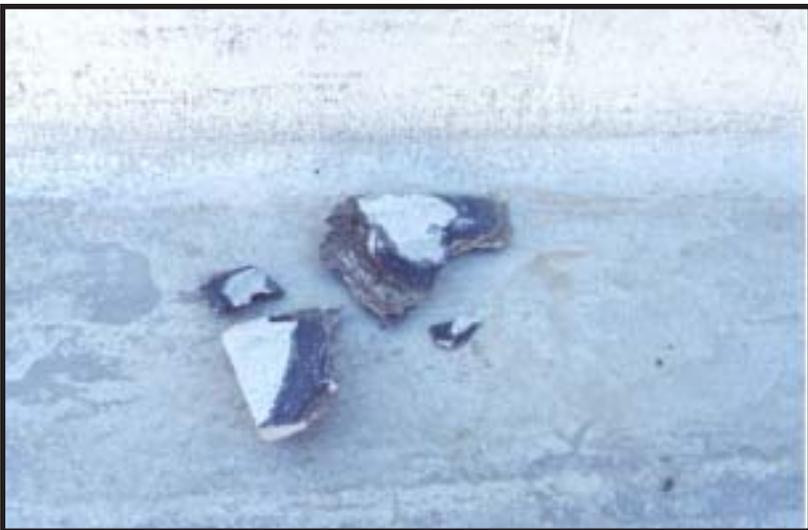
**oB-00005Eh – Plaster samples removed**

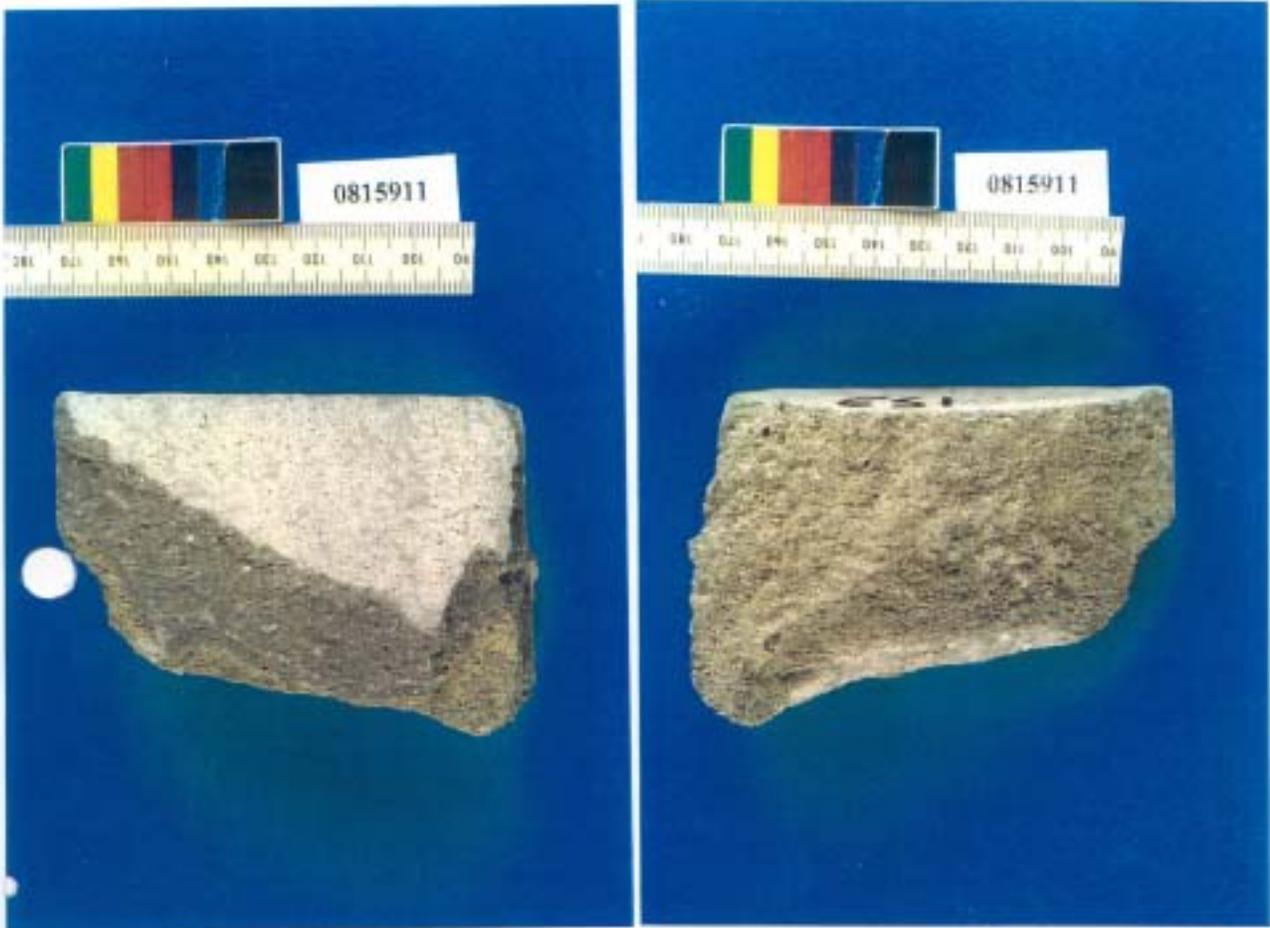
MAH112353 – Sample No. 0815911- ES1

Top & Bottom Views of As Received Sample

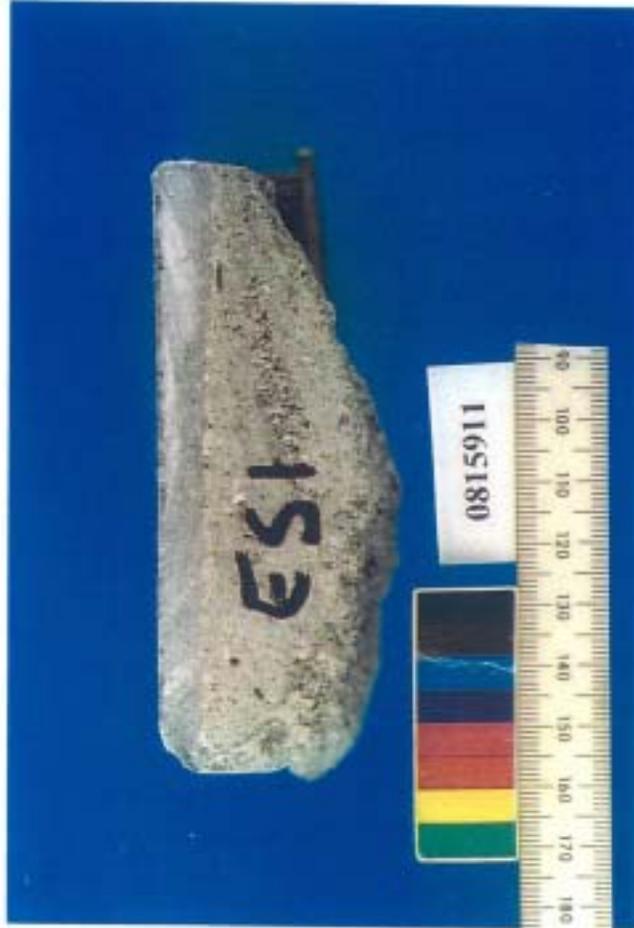
MAH112353 – Sample No. 0815911- ESI

Side View of As Received Sample

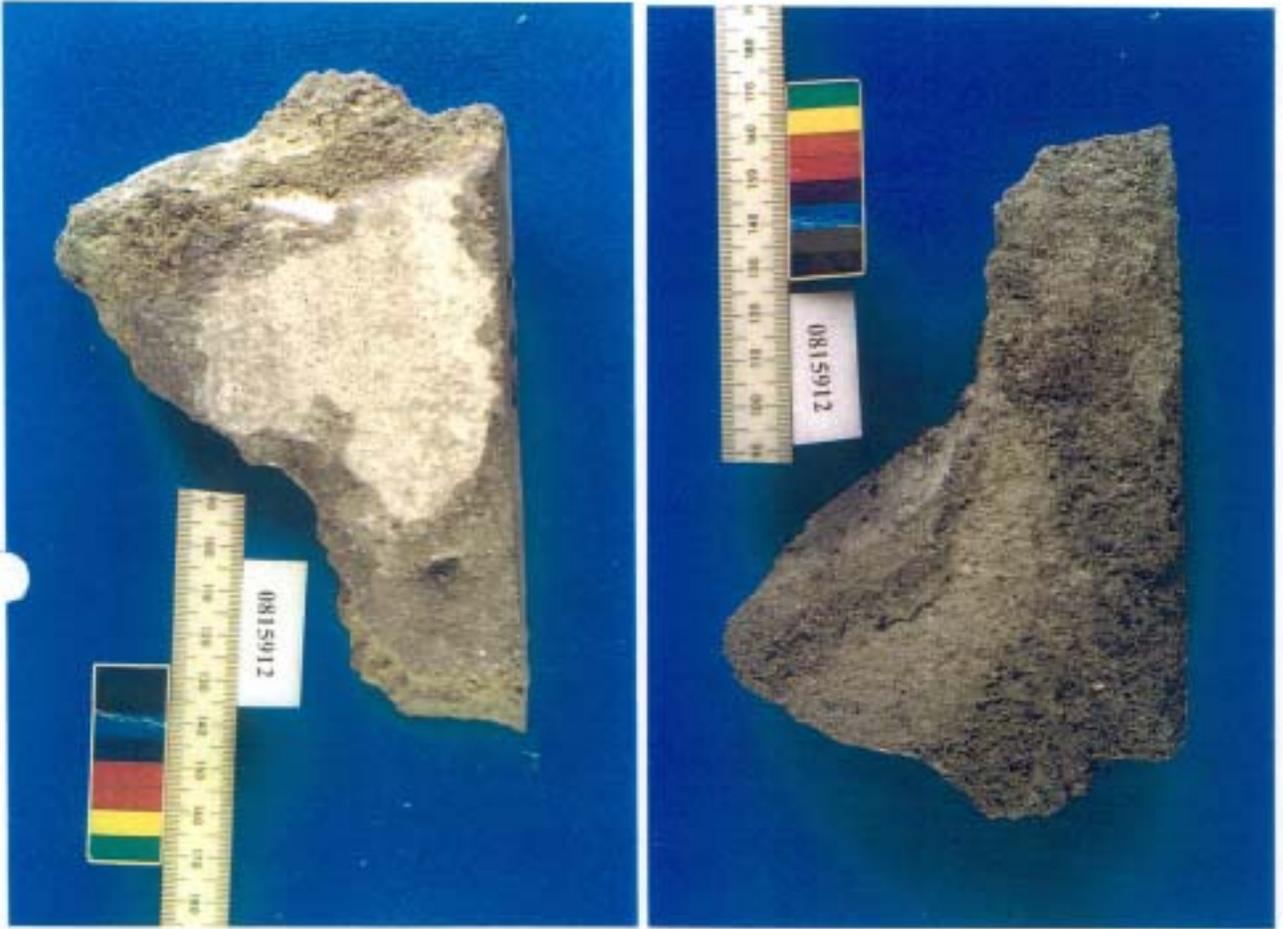
MAH112353 – Sample No. 0815912- ES2

Top & Bottom Views of As Received Sample

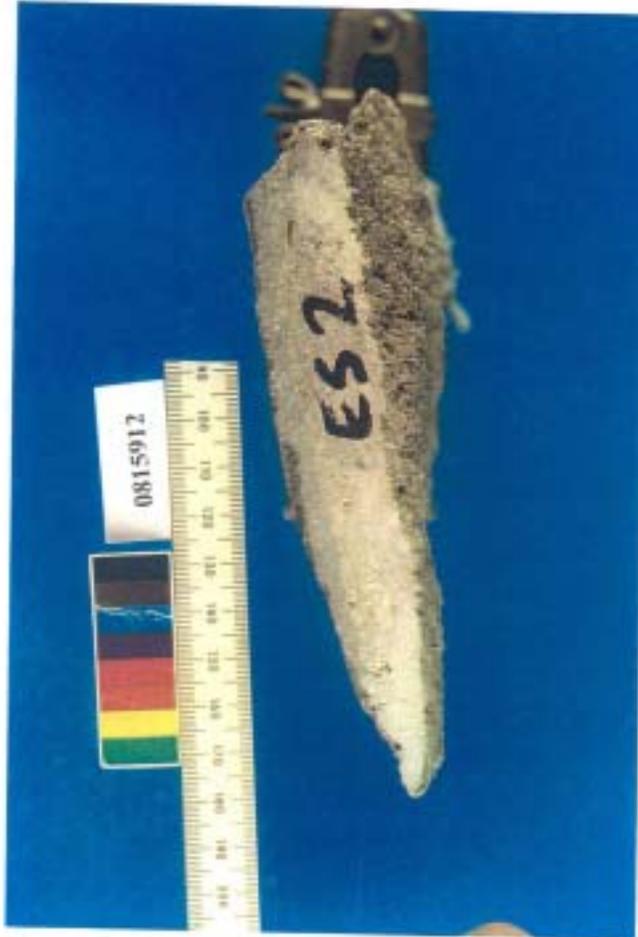
MAH112353 – Sample No. 0815912- ES2

Side View of As Received Core

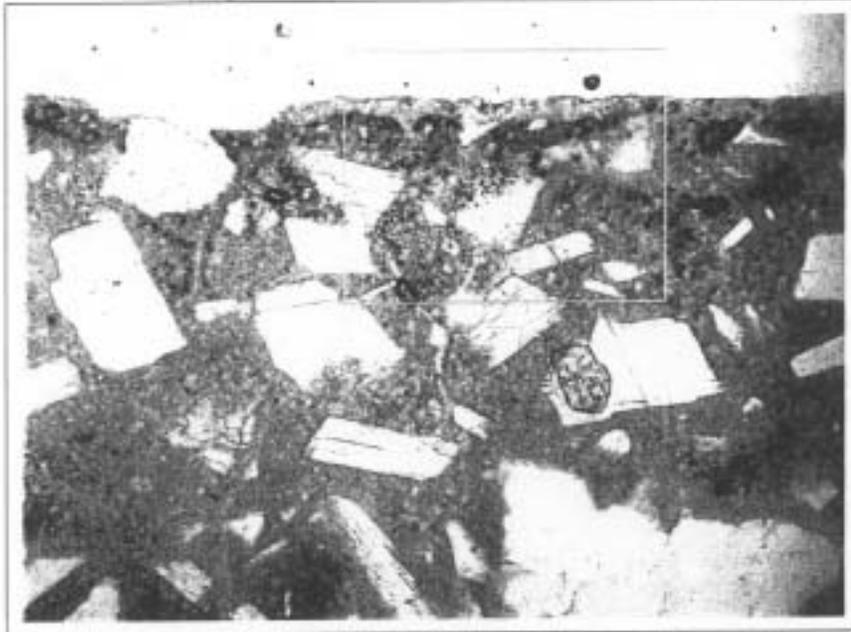
PHOTO NO. 5 - Stained section shows exterior surface at top of photo. Rectangle indicates area of Photo No. 7. (Magnification = 40X, Field length = 1.8 mm, Plane polarized light)

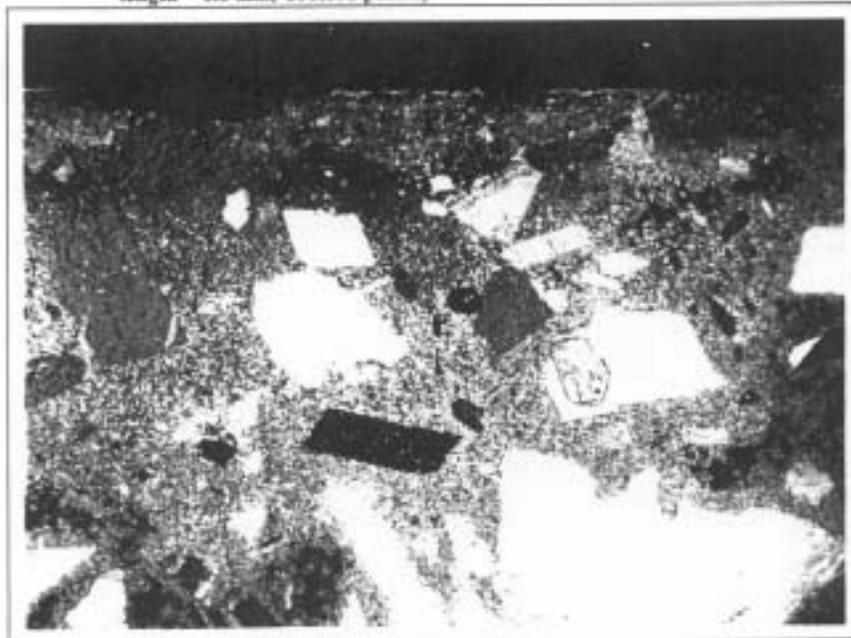
PHOTO NO. 6 - Same field of view as Photo No. 5 with crossed polars. (Magnification = 40X, Field length = 1.8 mm, Crossed polars)

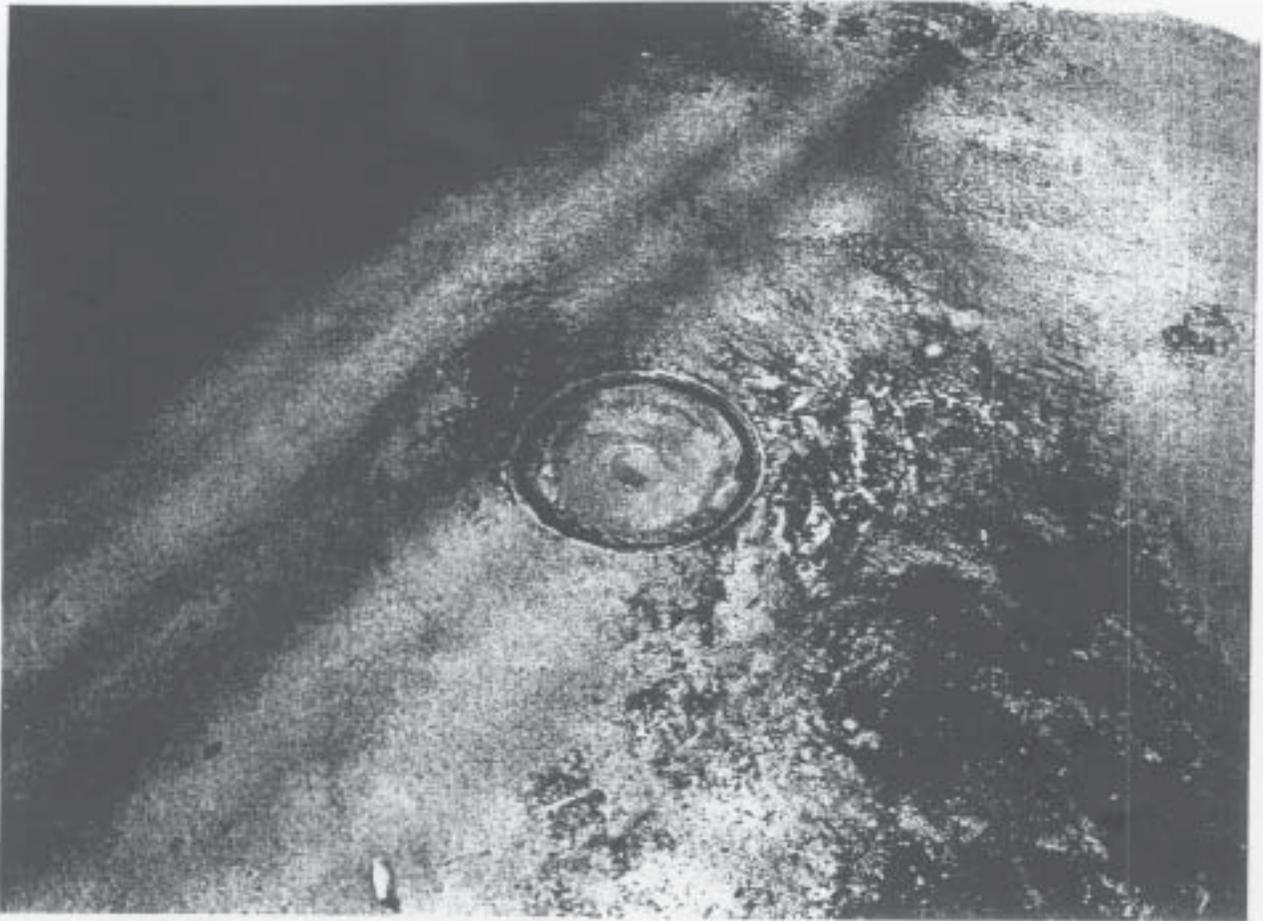
EXHIBIT B

DESCRIPTION: Corroded copper in skimmer basket
